# Circulating Water Line Internal Repair

**CUSTOMER**  
NRG

**SYSTEM**  
Carbon Fiber Pipe Reinforcement

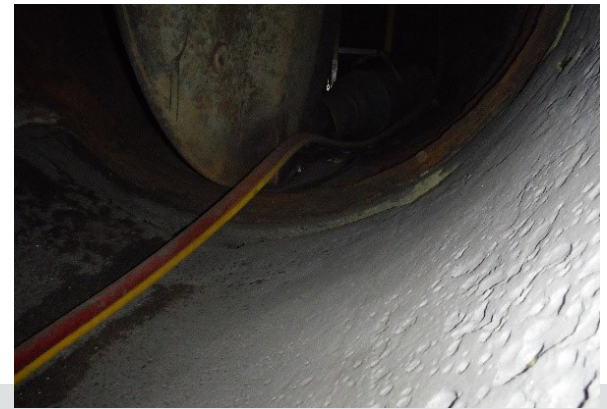
A significant leak on a circulating water line caused a forced outage at a power generation facility in the northeastern US. The piping system circulated 250,000 gallons of water per minute and was a critical component for the operation of the facility. The leak occurred on a 60" carbon steel pipe section of the circulating water line with an internal gunite liner. Once the gunite liner was removed and the steel was grit blasted, the full scope of the corrosion was revealed: several through-wall failures and many areas of deep pitting throughout the pipe (See Figure 1). A quick return to service and long-term reliability were critical factors when choosing the best pipe repair solution.

Figure 1 Deep Pitting in Host Pipe

After exploring a wide variety of pipe repair options, Advanced FRP Systems' composite carbon fiber reinforcement system was chosen. The composite system was engineered to fully restore the pressure capacity of this badly corroded pipe section, restoring the reliability of the circulating water system.

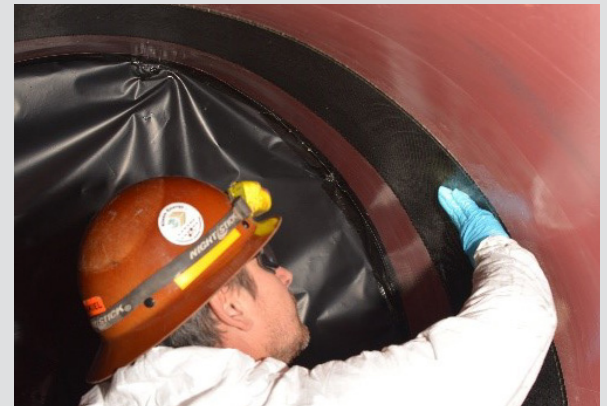
Figure 2 Application of Carbon Fiber

1. We removed the gunite liner from the leak area and grit blasted the steel to an SSPC SP-10 surface finish.
2. Deep pits and through-wall failures were filled with FRP Repair Putty to provide a smooth surface.
3. Two layers of high-strength, aerospace-grade carbon fiber were applied internally over the entire pipe segment, with an extra layer over any through-wall failures.
4. An immersion-grade, zero VOC epoxy topcoat was installed at 15 - 20 mils DFT.

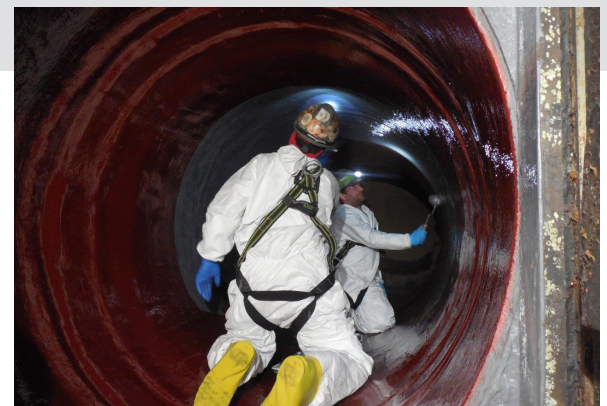
Figure 3 Application of HP-300 Epoxy
