FEATURED PROJECT

Hydrocarbon Pipeline Reinforcement

Carbon Fiber Pipe Reinforcement

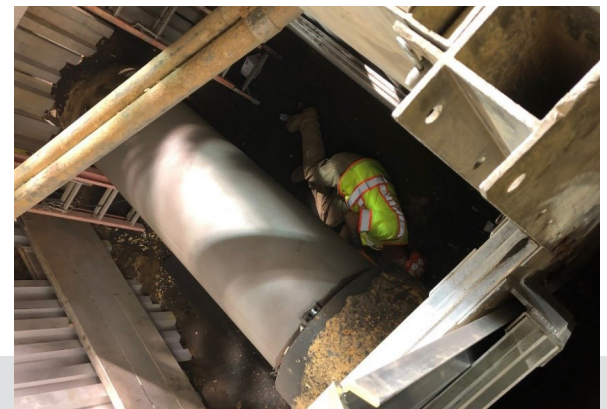
Figure 1 Pipe Surface After Grit Blasting

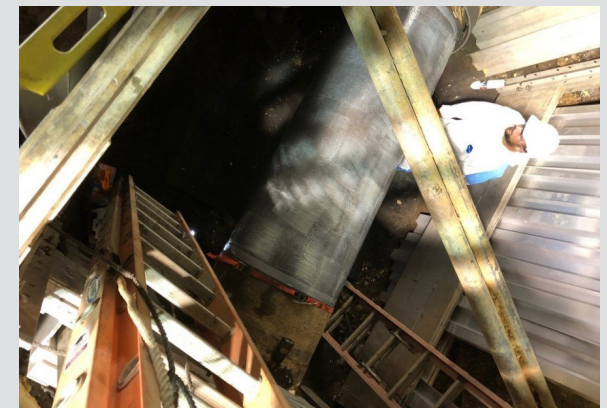
Figure 2 Application of Adhesive

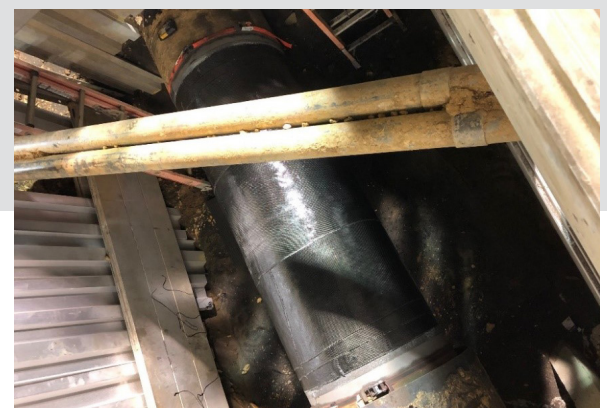
Figure 3 Final Carbon Fiber Repair

The entire repair was completed on time and under budget. The installation of the composite reinforcement took less than 3 hours. The 32-inch diameter pipe was reinforced with 3 layers of high-tensile strength, aerospace-grade carbon fiber composite technology.
