# Composite Tank Roof Repair

## REINFORCEMENT OF HYDROCHLORIC ACID TANK

Dallas Chemical Plant

Texas City, TX

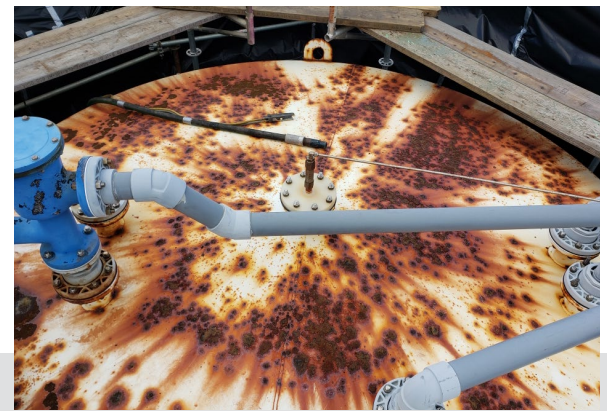
An inspection of the roof of a hydrochloric acid tank at a chemical manufacturing company revealed several through-wall failures. Traditional weld repair options were implausible as the roof was coated internally, had several injection ports and other interruptions present. Due to this and the desire to minimize the impact on production, an external repair while the tank was online was deemed appropriate. The repair needed to withstand constant exposure to hydrochloric acid vapor and have a UV-stable topcoat. As the full extent of corrosion was unknown, an engineering analysis was necessary to ensure the structural integrity of the tank.

Figure 1 Tank Roof Before Composite Repair

After a detailed finite element analysis was performed to ensure that the roof had sufficient structural strength, the plant opted for a high-strength, acid-resistant, carbon fiber reinforcement system as a repair solution. The system was chosen as it would be installed on the exterior of the roof, eliminate hydrochloric acid leaks, and prevent external corrosion.

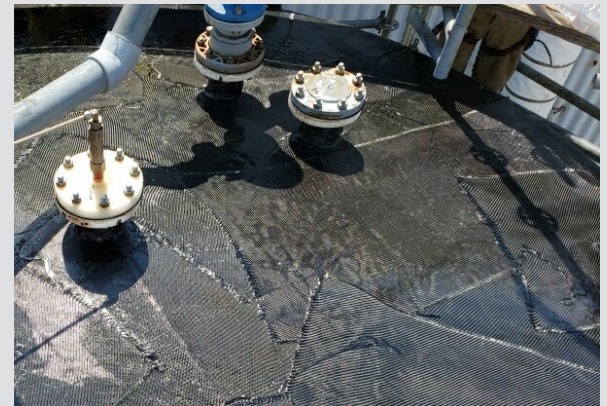
Figure 2 Carbon Fiber Installation on Tank Roof

1. The surface was grit blasted and primed with HP-400 Novo for maximum adhesion.
2. Pits, weld seams and through-wall failures were prepared for composite wrapping by using FRP Repair Putty.
3. Three layers of a high-strength, aerospace-grade carbon fiber composite was saturated with an acid-resistant epoxy, FRP 220-C.
4. After the composite cured, a UV-resistant urethane topcoat was applied.

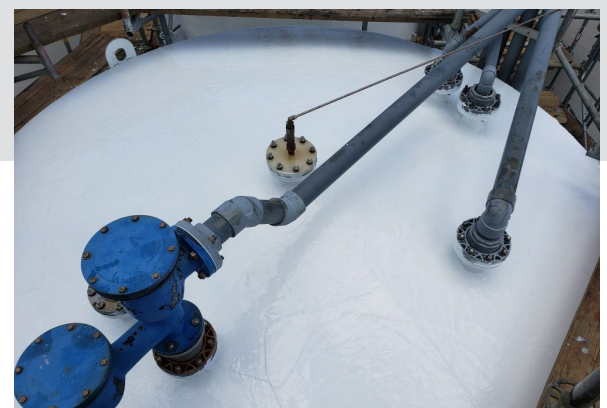
Figure 3 Final Repair After Urethane Topcoat

Though the tank was brought offline for a limited time during the repair, the entire repair was installed and fully cured well within the planned repair window. This was done at a fraction of the cost of replacing the tank roof and with minimal impact on production.
