# Carbon Fiber Repair Kit

Power Transmission System Operator

Boston, MA

June 2017

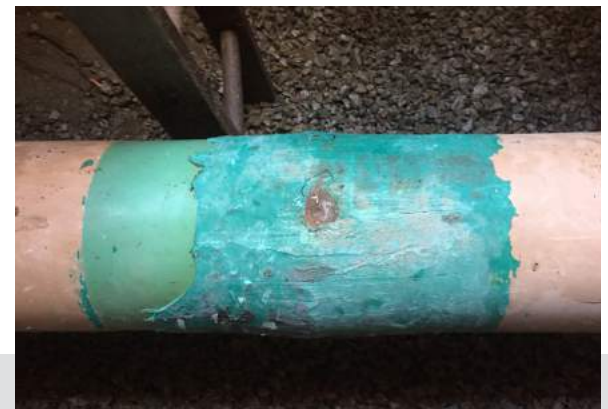
A power transmission system operator in the North East United States was experiencing spot corrosion in areas of their underground power transmission system where the pipe-type cables were installed via a horizontal directional drilling technique only five years from the date of installation. The corrosion was occurring primarily on girth welds, resulting in 50 - 100% wall loss, and led to several dielectric fluid leaks. The utility provider needed a solution that could repair the damaged girth welds even when extensive wall loss was present and proactively reinforce other potential problem areas of the host pipe; all while their assets were online.

Figure 1 Damaged Girth Weld Protection System with Spot Corrosion

An inspection found that the 8-inch, carbon steel pipes were experiencing localized corrosion due to the damaged coating on the girth welds. Advanced FRP Systems recommended our Carbon Fiber Repair Kit solution, a high-strength, fully structural, carbon fiber composite repair that would allow the utility to repair the corroded areas and tie back into the original barrier coating to prevent further corrosion. The all-inclusive kit is designed for spot repairs, is easy to install and includes all the composite materials and instructions required to perform a full repair in compliance with ASME PCC-2 (2018) Standard for Non-Metallic Repairs on Pressurized Equipment and Piping, even with 100% wall loss.

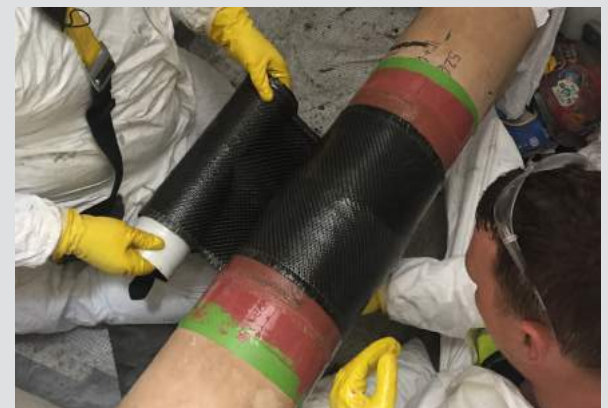
Figure 2 Application of Carbon Fiber Composite over the 8-inch Feeder Pipe

1. The existing coating was removed and the repair area was grit blasted.
2. The carbon fiber pipe repair kit was installed, including a galvanic barrier layer and impact-resistant epoxy topcoat
3. The system was allowed to cure for 24 hours and holiday tested to ensure continuity.
4. The existing corrosion barrier was extended to cover the termination points of the carbon fiber repair.

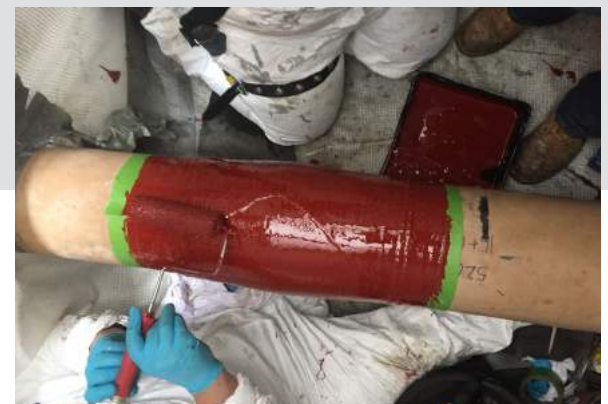
Figure 3 Application of HP-300 Topcoat System Prior to Holiday Testing
