# Composite Tank Repair

## CARBON FIBER REINFORCEMENT OF A RAW SEAWATER TANK

Rutgers Marine Research Group

Cape May, NJ

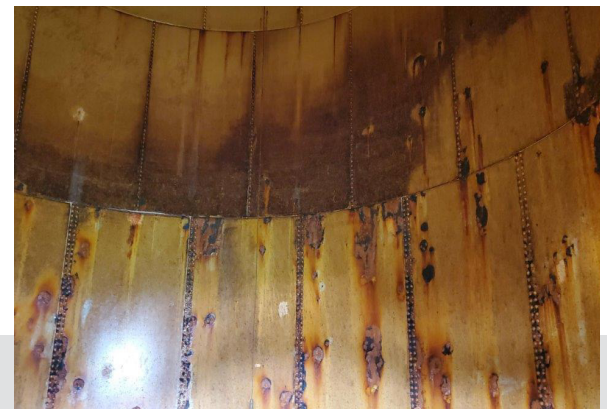
Upon inspecting a 23 ft. diameter, riveted steel tank containing raw seawater, numerous failures of the existing internal coating were found, allowing widespread corrosion of the substrate to occur. The internal corrosion was severe enough to cause multiple through-wall failures creating external corrosion under the existing insulation of the tank. As an alternative to a costly tank replacement due to the severe corrosion, the facility looked to Advanced FRP for a reliable, cost-effective composite solution. The composite could not contain any solvents or other small molecules that could leach into the seawater and affect marine life at the facility.

Figure 1 Extensive Internal Corrosion of the Tank was Documented After Clean-up

After assessing the condition of the tank and determining that the majority of the tank had less than 50% wall loss, a solution was designed that would enhance the strength of the existing tank while repairing the existing through-wall failures and eliminating the areas of internal corrosion on the substrate.

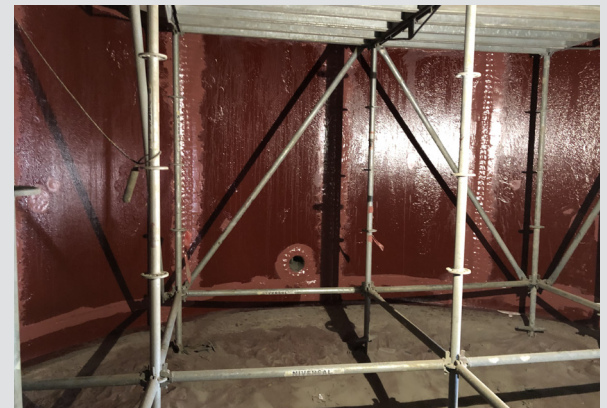
Figure 2 HP-300 Epoxy was installed at 15 - 20 mils and FRP Repair Putty covers the Rivets

1. The tank was cleaned, and then grit blasted to an SSPC SP-10 Near-White metal finish.
2. HP 300 Epoxy was applied via brush/roller at 15 - 20 mils DFT to the entire tank. FRP Repair Putty was then used to fill in any deep pitting and to cover internal rivets.
3. FRP 110 HT Tack was applied as a tack coat over the bottom tier of the tank before two layers of a high-strength, bi-directional carbon fiber composite (CF-500 BD saturated with FRP 210 HT Saturant) were applied.
4. A final coat of HP-300 Epoxy was applied via brush/roller at 15 - 20 mils.

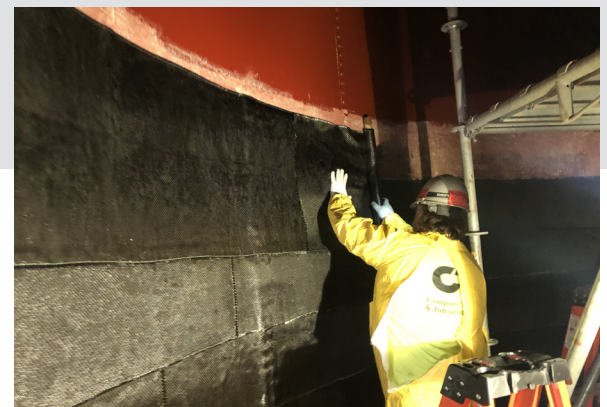
Figure 3 Installation of the High Strength Carbon Fiber on the Lower Tier
