# Active Leak Mitigation & Composite Reinforcement of Fiberglass Pipe

Major Chemical Manufacturer

Alberta, CAN

October 2016

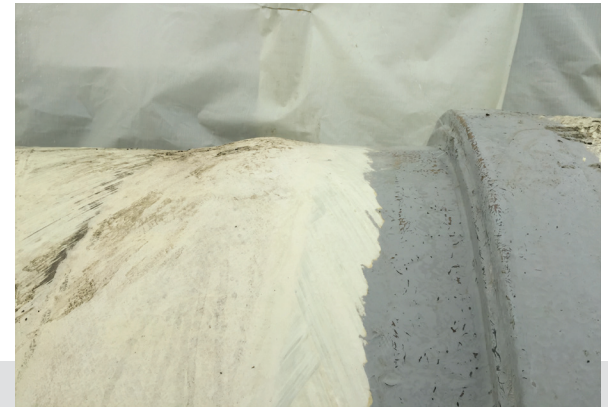
An inspection of a cooling tower at a chemical manufacturing facility found leaks present on the fiberglass header pipe with a bell and spigot design. The design allowed the pipe to taper from 72 inches to 24 inches in diameter along its span. The leaks were mainly present at the joint of the pipe including areas where previously installed fiberglass-based repairs did not perform as expected. As the cooling tower was critical to the operation of the facility, it could not be taken offline and any repair needed to be completed with the pressurized pipes actively leaking cooling water.

Figure 1 Close-Up of Leaking Pipe At Previous Fiberglass Repair

Advanced FRP Systems designed a two-part solution for this challenging pipe repair: a moisture-cured urethane wrap to stop the active leak on the pressurized piping system and a high-strength carbon fiber composite wrap to provide a permanent repair.

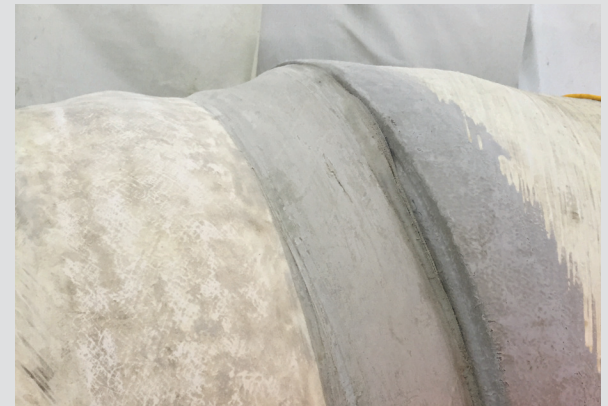
Figure 2 Joint After Leak was Repaired with GF-130 MCU

1. After the surface was thoroughly cleaned with a wire brush, a combination of Steel-Stik putty and GF-130 MCU wrap was used to temporarily stop the leak.
2. The step down of the joint was then filled in with FRP Repair Putty, a high-build epoxy material.
3. The entire circumference of the pipe was sanded with 60-grit sandpaper and wiped down.
4. Four layers of CF-500 BD, a bi-directional carbon fiber fabric, were saturated with FRP 200 Saturant, a 100% solids epoxy saturating resin, and wrapped around the pipe.
5. HP 300 Epoxy was rolled on the composite at 15 - 20 mils as a topcoat

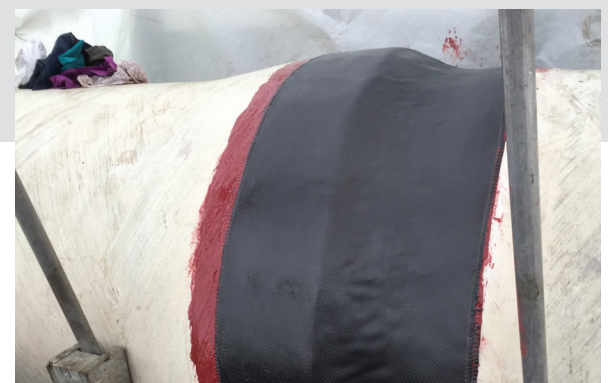
Figure 3 Permanent Repair with High-Strength Carbon Fiber
