Composite Pipe Repair

PERMANENT COMPOSITE REPAIR FOR ACTIVE PIPE LEAK

Steel Manufacturing Facility

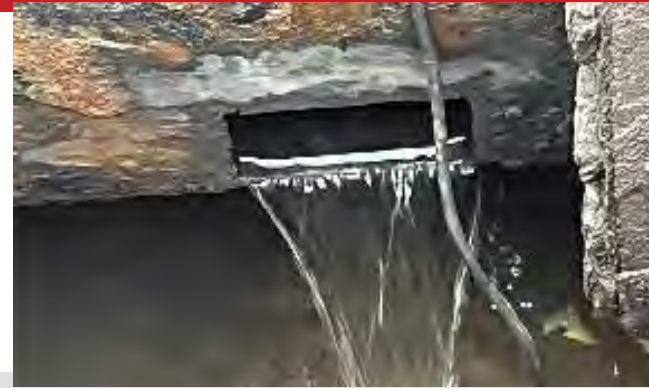
A major leak in a process water pipe caused by a failed weld repair resulted in a partial shutdown at a steel manufacturing facility. The heat from weld repairs is known to damage internal coatings, resulting in localized corrosion and ultimate failures. Major failures are difficult to fix, and time was critical because of the partial plant shutdown. The pipes were depressurized, but not completely drained, so water was still leaking while the repair was installed. Fortunately, a leak repair specialist was already onsite and could work towards implementing a solution.

Figure 1 Identified holes in the tank were repaired with carbon fiber

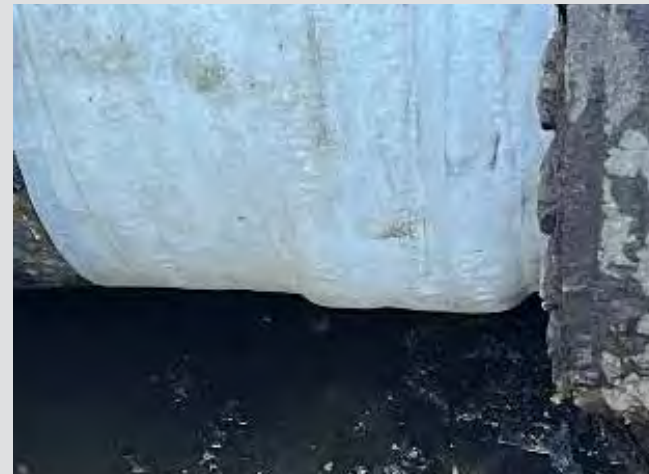
Figure 2 Repair putty filled in pitting

1. Grit blasted to SSPC-SP 6/NACE No.3 Commercial Blast cleanliness.
2. Used HP 110 HT Tack to fill in pitting and adhere the fabric to the pipe's complex geometry.
3. Externally wrapped four layers of CF-500 BD, a bi-directional carbon fiber fabric, saturated with FRP 211 HT Saturant.
4. A fast set polymer was injected into the wrap annulus where water was observed weeping through the repair area.
5. Wrapped an additional four layers of CF-500 BD saturated with 211 HT around an area with a large through-wall failure.

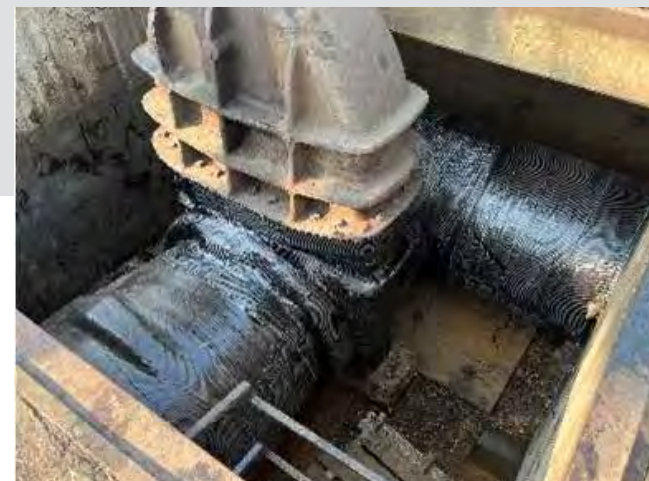
Figure 3 Permanent pipe repair using carbon fiber composites

Once the leak was under control using a moisture-cured urethane system, surface preparation could be performed by thoroughly cleaning and grit blasting the remainder of the pipe. The carbon-fiber composite was then installed over the outside of the pipe.
