Composite Pipe Repair

ACTIVE LEAK REPAIR AT WATER TREATMENT PLANT

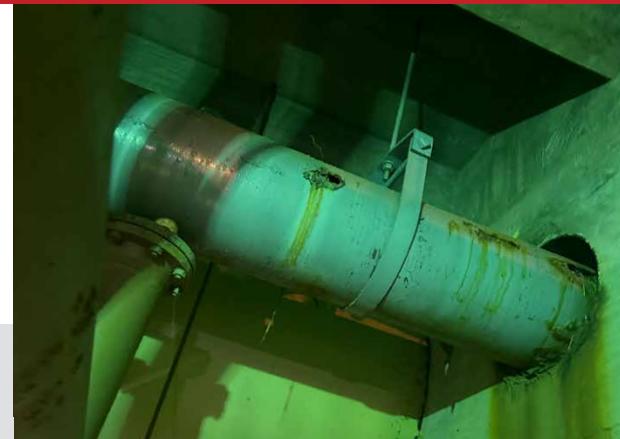
A severe pipe through-wall failure caused by internal corrosion at a wastewater treatment plant was a major cause of concern. The 24" pipe in question transported rainwater in the basement. It ran along the ceiling between two walls and was held in place by pipe supports. The challenge was finding a repair solution to avoid full replacement of the pipe segment and accommodate the concrete walls and pipe supports. The damage was so extensive that when it rained, "it was like a waterfall was coming down from the basement," according to a plant employee.

Figure 1 External pipe supports and surrounding concrete walls posed challenges to this pipe repair

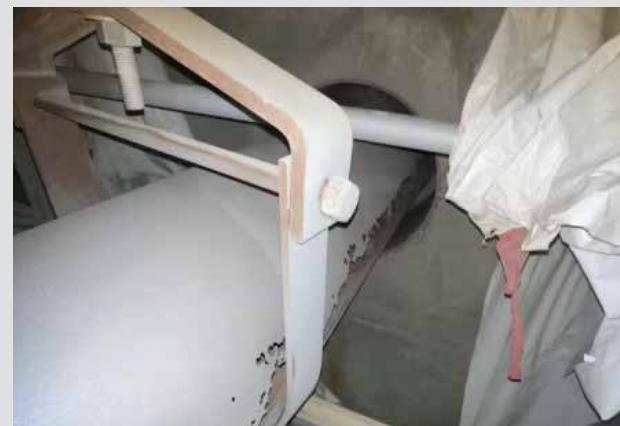
Figure 2 Carbon fiber patches addressed through-wall failures

1. The surface was cleaned and grit blasted to SSPC SP 10 standards for optimal adhesion of the composite repair system.
2. The through-wall failures were filled in with FRP Repair Putty before applying the composite system.
3. A layer of glass fiber composite wrap was applied to serve as a barrier between the carbon steel substrate and the carbon fiber composite wrap.
4. Six layers of carbon fiber and glass fiber composite wrap (CF-500 BD) were applied to the repair area. The layers were saturated with FRP 210 HT Saturant prior to wrapping.

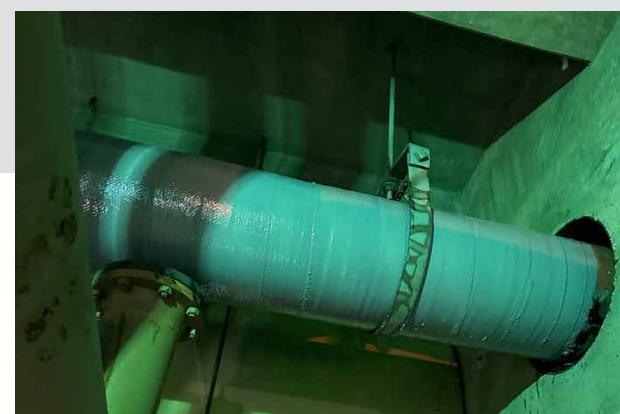
Because composite systems are adaptable to complex geometries and provide proven structural reinforcement without replacement, this solution was a perfect fit for the wastewater treatment plant. Six months later, the system was performing optimally, and no further incidents were recorded.

Figure 3 The composite repair system successfully stopped the leaks and reinforced the pipe
