FEATURED PROJECT

Underground Power Transmission Lines

Power Transmission System Operator

LOCATION New York, NY APPLICATION TEAM Various DATE OF APPLICATION May 2019

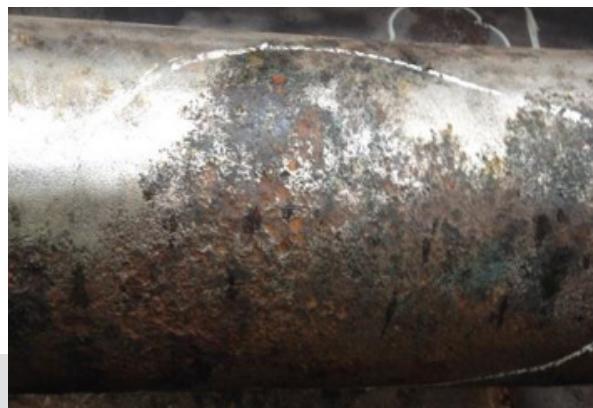
A major regional power transmission systems operator found the traditional methods of leak repair and reinforcement of their underground highpressure, fluid-filled (HPFF) transmission cable system was not keeping up with the level of corrosion present in their system, impacting the availability of service to millions of customers. Many of these pipe-type cables have been underground for more than 50 years, well past the service life of the protective coating on the pipe exterior. Even with a sophisticated cathodic protection system in place, stray current from other critical infrastructure was accelerating the corrosion of the HPFF cable system.

Figure 1 Typical Corrosion Found

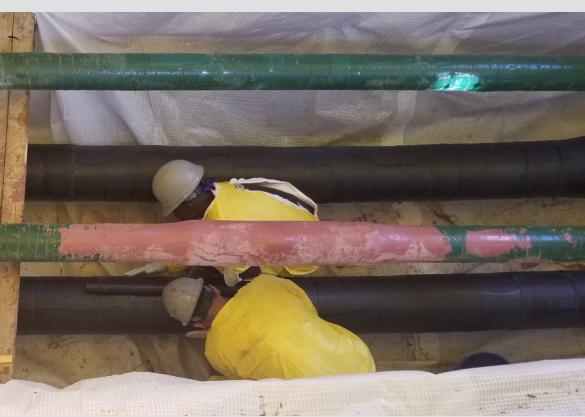
Figure 2 Installation of CF Composite

Over six months, six layers of high-strength, aerospace-grade carbon fiber composite were applied over 6,000 linear feet of pipe. The application included the identification of 3 ft. adhesion zones every 100 linear feet of pipe that were grit blasted to SSPC – SP 10 standards and allowed the composite to adhere directly to the pipes. The pipe sections between adhesion zones were then encapsulated by the structurally independent composite system.

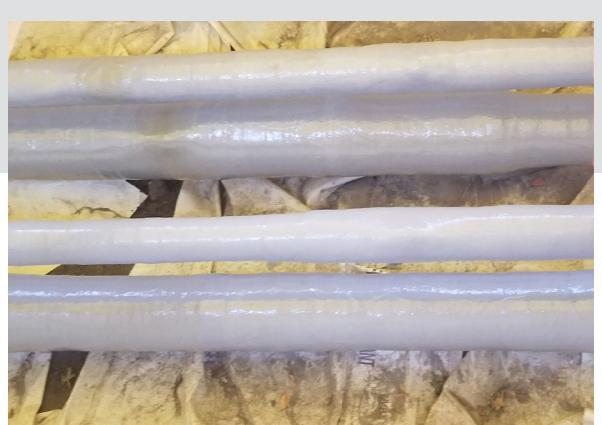
Figure 3 After Installation
