## FEATURED PROJECT Carbon Fiber Repair Kit Application

## OIL PIPELINE

CUSTOMER QEP Resources

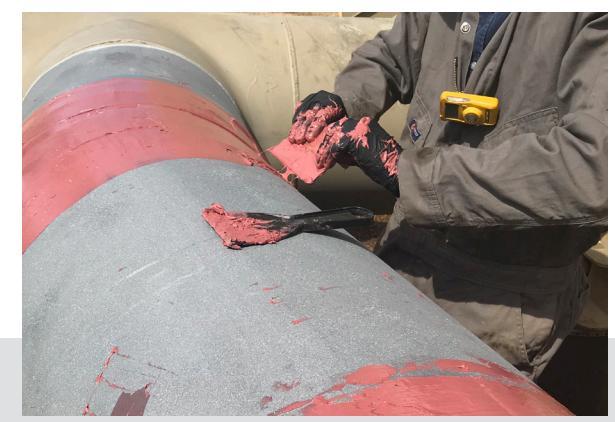
Figure 1 Smoothing of the Pipe and Weld Seams with FRP Repair Putty

- A 6 ft. repair area was identified and grit blasted to remove the existing coating and provide a profile for adhesion with >80% wall loss.
- 2. The area was primed with FRP 120 HT, high-strength adhesive.

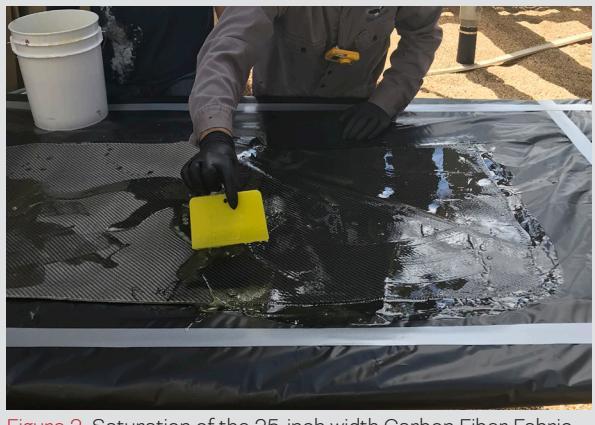
Figure 2 Saturation of the 25-inch width Carbon Fiber Fabric

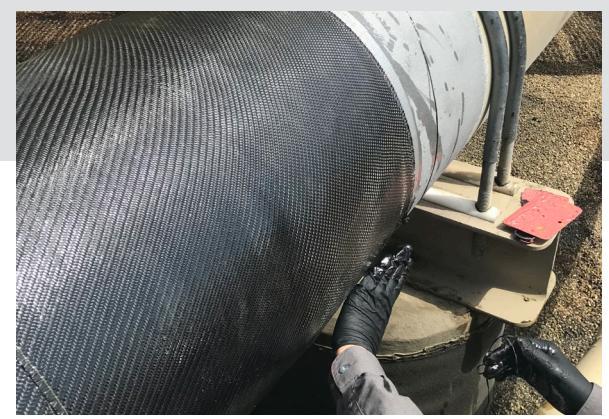
Figure 3 Application of Carbon Fiber Composite Reinforcement

- Six layers of carbon fiber were installed over the repair area by using 3 of the Large Carbon Fiber Repair Kits
- **4.** The system was fully installed in one shift and allowed to cure for 24 hours.
