## FEATURED PROJECT Composite Tank Repair

## COMPOSITE REINFORCEMENT OF A TURPENTINE TANK

## **CUSTOMER** Georgia Pacific

LOCATION Cedar Springs DATE OF APPLICATION June 2021

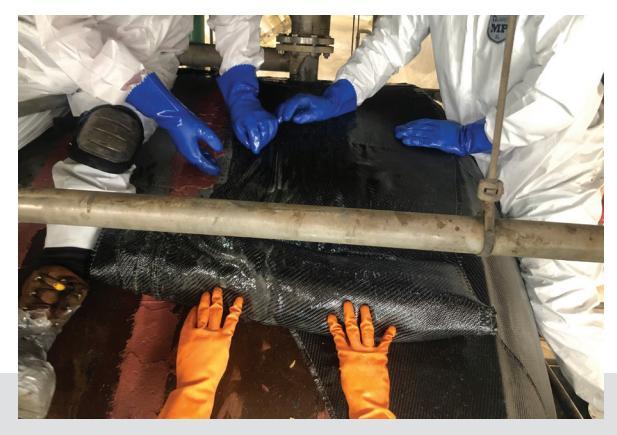
Figure 1 Close-up of the Installation of Carbon Fiber Composite

- After spot welds were completed, the exterior was grit blasted to an SSPC SP-10 Near-White Metal finish.
- 2. All weld seams and pitting were covered in FRP Repair Putty.
- FRP 120 HT was applied to the tank surface at 5 10 mils via a roller.
- 4. Three layers of carbon fiber were saturated with FRP 211 HT Saturant and wrapped around the tank while in service, operating at 120 - 160°F
- 5. HP 400 Novo topcoat was rolled on the composite at 15 20 mils.

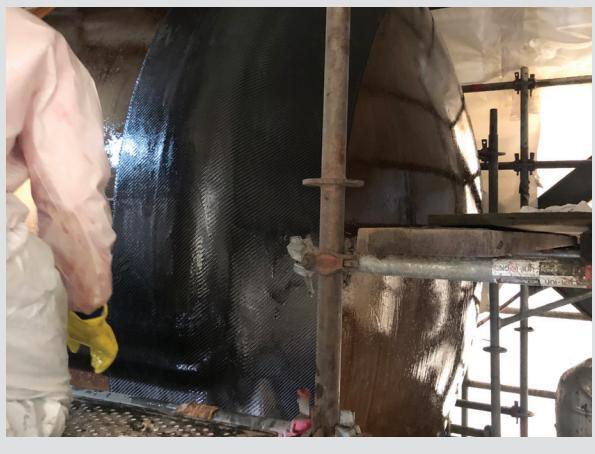
Figure 2 Reinforcement of the Bell End of the Cylindrical Tank

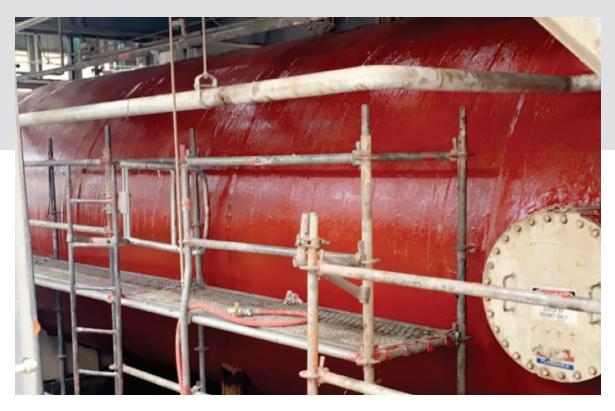
Figure 3 Turpentine Tank after Application of the HP-400 Novo Topcoat
