Outstanding Protection in Tough Immersion Conditions

Coating Solutions for Water Immersion

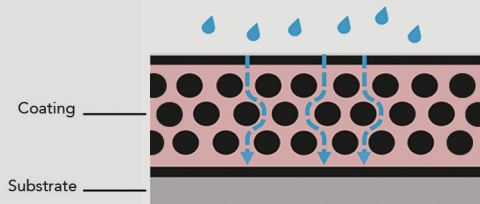
Traditional Fillers

Traditional fillers like silica and calcium carbonate have a mostly round shape so they do not enhance permeation resistance.

Blisters form as water molecules reach the surface and condense. Osmotic blistering is the leading cause of failures in water-immersion coatings.

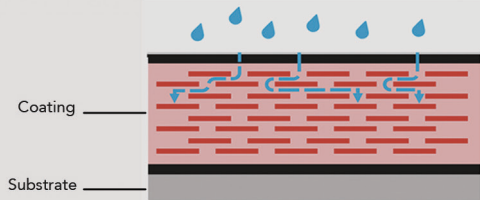
Lamellar Fillers

Glass flakes offer the best-in-class enhancement of permeation resistance in coatings by creating a "torturous path" for water.

Reducing the rate of water permeation through a film extends the service life of the coating system and prevents the formation of blisters.

Advanced FRP Systems designed a range of coatings containing **glass-flake fillers** that decrease the rate of water permeation through the coating by an order of magnitude. This allows us to provide a **20-year service life**, even in aggressive services like hot water, salt water or purified water.

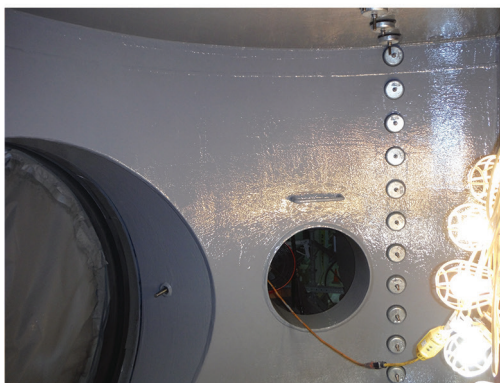
A condenser waterbox was experiencing extreme corrosion due to a failed coating system with the most significant corrosion on the hot side of the condenser. HP-300 GF was installed to provide long-term protection in operating temperatures up to 120°F and was compatible with the existing cathodic protection system.

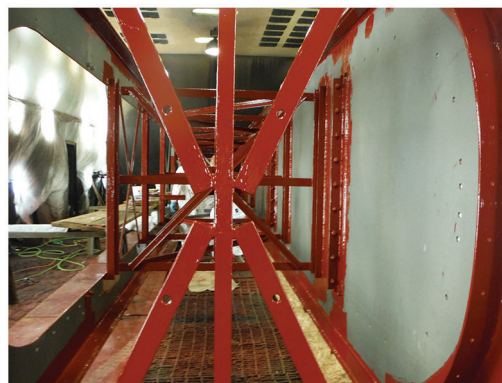
A traveling water screen at a power generation facility was experiencing rapid corrosion as a result of Microbially Influenced Corrosion. HP-300 Epoxy was applied successfully, pinhole-free, despite the complexity of the unit. HP-300 Epoxy reduces the accumulation of microbes on the surface and protects from chemical attack.

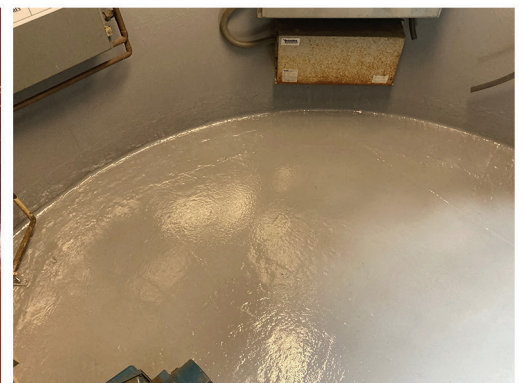
An underground pumping vault frequently filled with groundwater contaminated with road salts causing the previous coating to completely fail and allowed through-wall failures to develop. HP-300 Elastomer was installed to provide excellent resistance to intermittent water-immersion and physical abuse from maintenance activities.
