# Don't let a pipe failure shut you down

## Composite Reinforcement Solutions for Circulating Water Lines

## Installation Spotlight

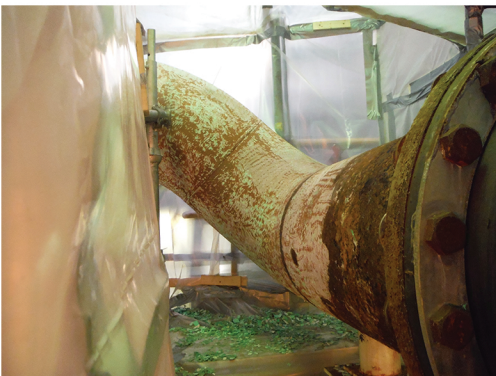
**Before:** A New York power generation facility was experiencing systemic corrosion in their circulating water lines. A section of 30-inch diameter, carbon steel pipe was experiencing internal and external corrosion and required immediate attention. Instead of pipe replacement, a composite pipe repair was chosen to provide a 50-year life extension.

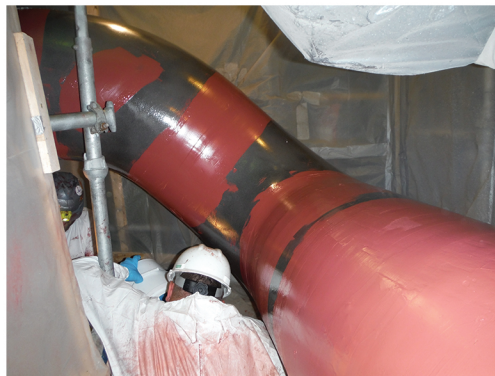
**During:** Advanced FRP Systems designed a structurally independent carbon fiber composite pipe with a flange-to-flange wrap design, to completely rebuild this section of piping. The external application of the composite allowed the repair to be done without draining the circulating water line, minimizing the required downtime for the repair.

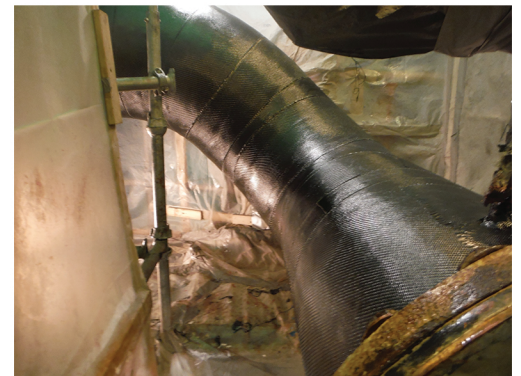
**After:** The carbon fiber pipe repair system was installed on-time and on-budget during a busy plant outage. The system is engineered to withstand more than double the design pressure of the original circulating water line. This composite pipe repair will provide a 50-year, maintenance-free service life, even in aggressive saltwater immersion conditions.
