FEATURED PROJECT

Circulating Water Lines External Repair

CUSTOMER
NRG Energy

SYSTEM
Carbon Fiber Composite Pipe Reinforcement

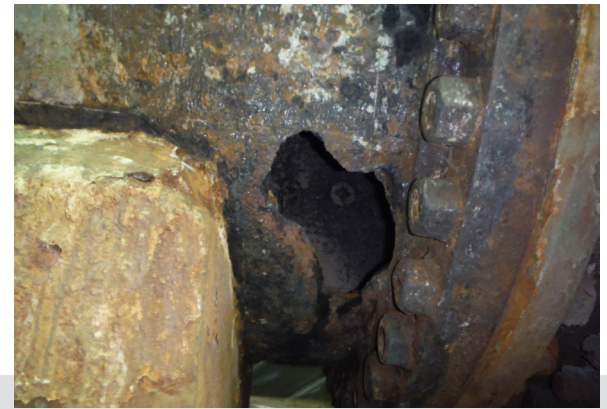
During a planned outage, the unit was drained and inspected. It was found that the fiberglass tape had not properly adhered to the host pipe, allowing moisture to build up and accelerating the rate of corrosion leading to the formation of several large holes.

Figure 1 Pipe Before Repair

The plant opted for a high-strength, structurally independent composite carbon-fiber reinforcement system as a repair solution. In order to install this solution, the pipe surface had to be grit blasted for proper adhesion and relatively smooth for fabric lay-up.

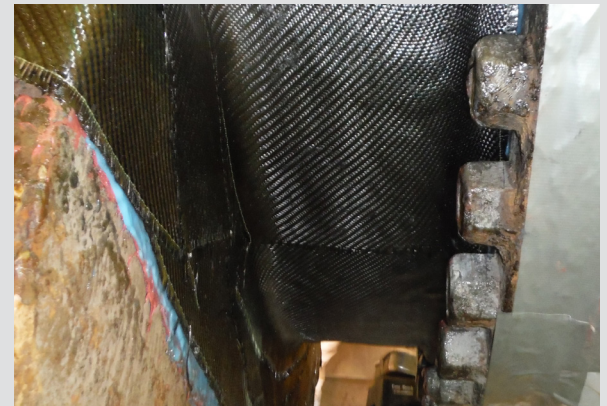
Figure 2 Carbon Fiber Wrapping

1. Pits, weld seams and large through-wall failures were prepared for composite wrapping by using fabric tape and our Ceramic Repair Putty.
2. Three layers of a high-strength, aerospace-grade carbon fiber composite was wrapped around the pipe exterior.
3. The carbon fiber was saturated with a specialty, zero VOC epoxy resin that provides outstanding adhesion to blasted steel.
4. After wrapping the pipe was coated with an immersion-grade epoxy coating.

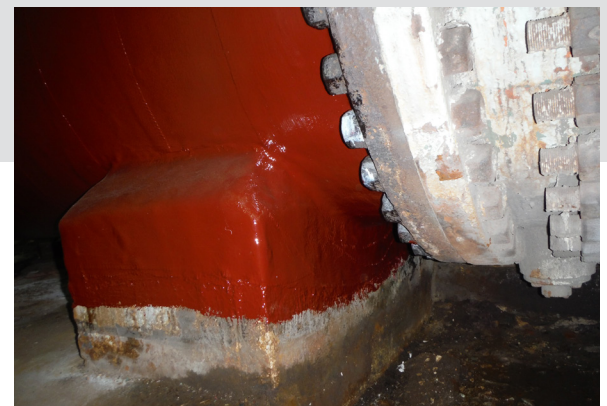
Figure 3 Application of HP-300 After Repair

The system was installed and cured during the planned outage. The installation was completed without significant delay, despite the unexpected size of the through-wall failures. The unit came back online without any leaks and this section continues to operate without issue.
