# Composite Tank Repair

**ACID AND CAUSTIC TANKS**

Power Generation Facility

Beulah, North Dakota

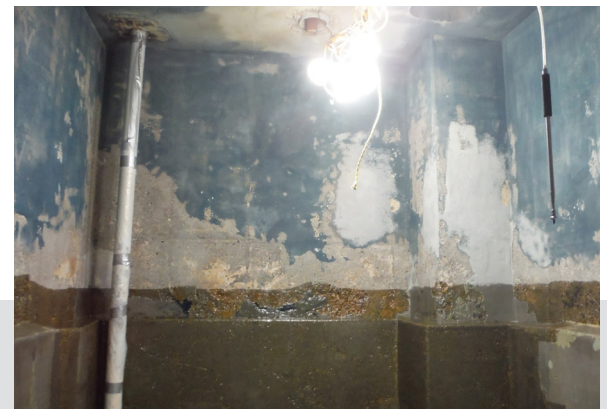
Figure 1 Tank After Application of FRP 200 Sealer to Bottom Half

1. Any failed coating was removed and the concrete was grit blasted.
2. FRP 200 Sealer was applied at 3 - 5 mils to increase adhesion and reduce pinholes.
3. EM-110 was used to fill in any deep pitting
4. An adhesive coat, FRP 110 HT, was applied to the walls then high-strength carbon fiber reinforcement was hung vertically, conforming to the hard edges of the acid brick and installed in two layers to provide a crack-resistant coating without any pinholes or voids.
5. A novolac epoxy, HP-400 Novo, was installed in two coats at 40 mils DFT.
6. Coatings were allowed to cure for 48 hours before return to service.

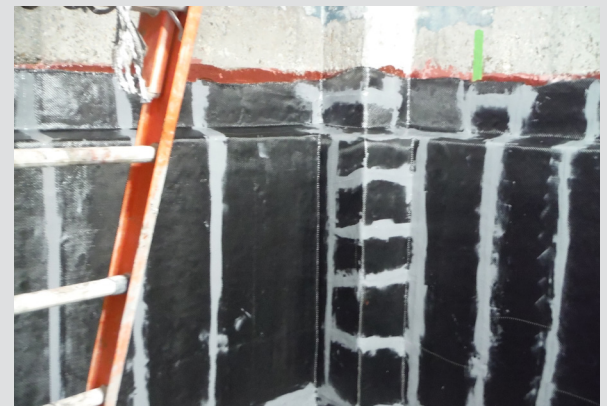
Figure 2 Carbon Fiber Reinforcement Applied over Edges and Corners

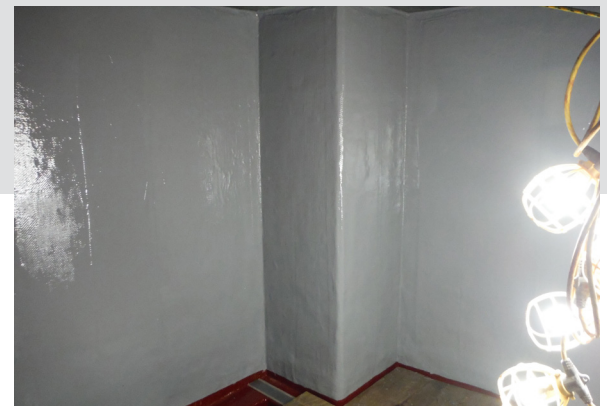
Figure 3 After Application of Second Coat of HP-400 Novo Topcoat
