FEATURED PROJECT

Water-Immersion Coatings

APPLICATION OF COATING IN A HIGH-SALINITY ENVIRONMENT

Water Treatment Facility

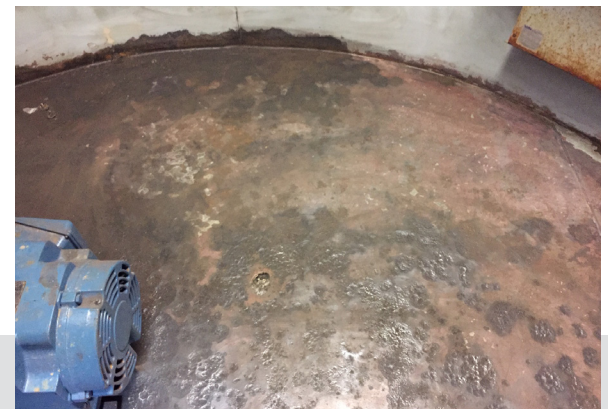
During an inspection, a water treatment plant found groundwater was leaking into the chamber of one of its underground pumping vaults. The damage was primarily attributed to internal corrosion of the steel on the floor and lower sections of the wall, with multiple through-wall failures identified. A solution had to be installed that would prevent groundwater infiltration, reinforce the corroded floor-to-wall joint, and resist periodic immersion in water with a high salinity. The solution also needed to be installed without grit blasting the repair area as the sensitive pumping equipment could not be removed or safely protected.

Figure 1 Extreme Corrosion with Through-Wall Failures After Surface Preparation

To prepare the repair area, the failed existing coating was removed via Bristle Blasting and a surface-tolerant epoxy primer was installed to maximize adhesion to the exposed steel. Pitting and holes were filled in with a high-build epoxy putty then reinforced with two layers of a high-strength woven fiberglass mat. An elastomeric epoxy was then applied to minimize any stress from thermal cycling and provide maximum impact and abuse resistance to the cured system.

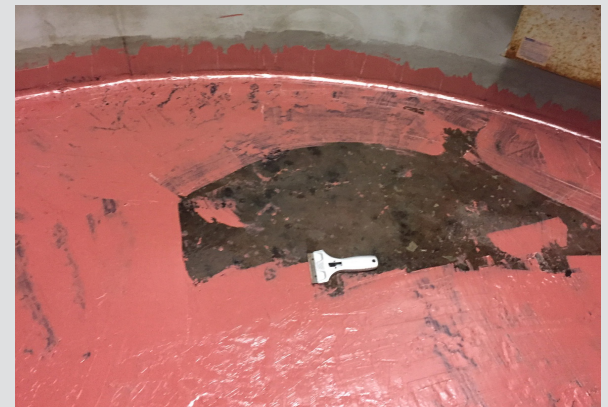
Figure 2 Pitting Repair with FRP Repair Putty Prior to Glass Reinforcement

1. The steel was Bristle blasted then primed with FRP 201 Sealer.
2. FRP Repair Putty was used to fill in existing pitting and provide coves in the corners.
3. Fiberglass was saturated with FRP 200 Saturating resin and installed around the circumference of the vault to reinforce the floor-to-wall joint.
4. Two layers of HP-300 Elastomer were applied via roller at 15 – 20 mils per coat.

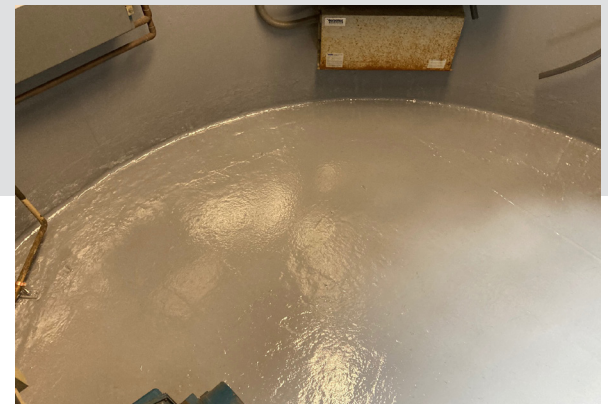
Figure 3 Vault Floor After Rebuild and Coating Application

The final system provided an immersion-grade, reinforced epoxy that tied into the existing internal coating to prevent future corrosion from the inside of the vault.
