ABRASION RESISTANT COATINGS

INTERNAL COATING FOR COAL PULVERIZERS

Louisville Gas and Electric

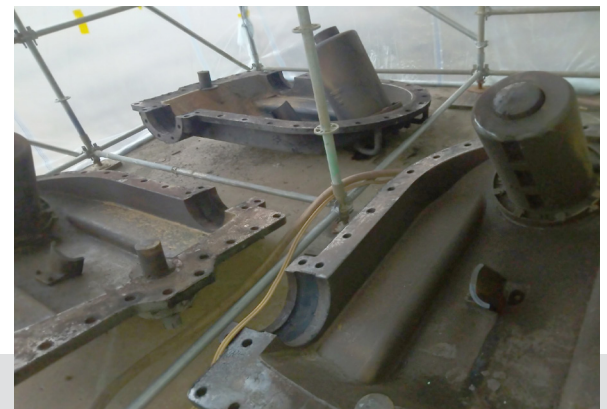
A power plant operated by LGE-KU discovered extensive internal degradation of their coal pulverizers during a routine inspection. Historically, degradation of the uncoated steel was not an issue however a shift in coal makeup created a combined corrosion/erosion mechanism due to an increase in the moisture, chloride, and sulfur content of the coal. The general operating conditions of the pulverizers include continuous abrasion from coal ranging in size from pea gravel to baby powder with internal temperatures between 130 - 150°F. A non-combustible and highly abrasion-resistant solution capable of withstanding periodic mill fires up to 800°F was required.

Figure 1 Pulverizer Doors Prior to Surface Preparation.

1. The surface of the pulverizer doors were first cleaned with a wire wheel to remove debris and then grit blasted to ensure a proper bond for the Ceramic Repair Putty HT.
2. Two layers were applied via trowel over the entire surface of the doors: a fill layer to fill in all the deep pitting and uneven textures on the surface of the doors, and a second layer at 125 mils thick.
3. The Ceramic Repair Putty HT was then allowed to cure for 24 hours at 75°F prior to returning to service.

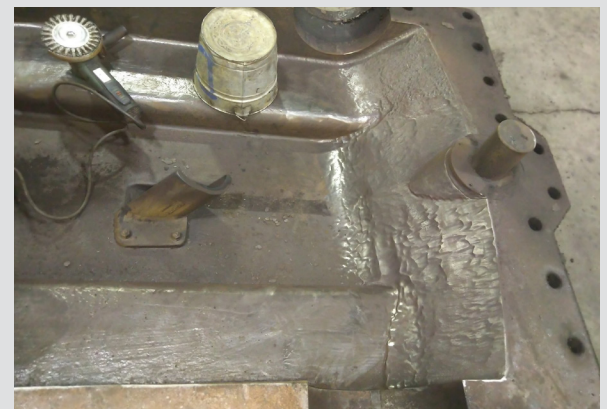
Figure 2 Close-up of Extreme Wear and Corrosion on Interior Surface of Door after Cleaning.

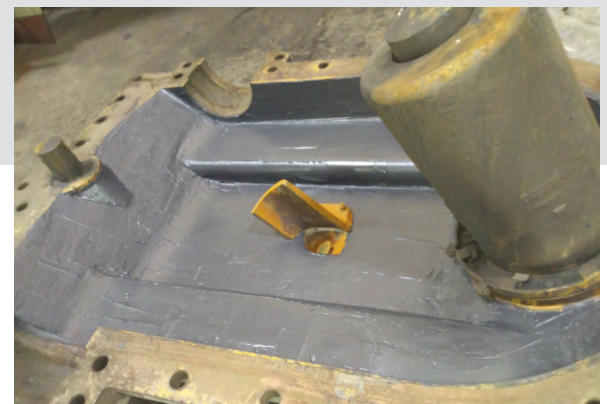
Figure 3 Ceramic Repair Putty HT Applied At Over 1/8 Inch Total Thickness.

LGE agreed to a test of Advanced FRP's recommended high-temperature, ceramic-filled, novolac epoxy coating system. The existing maintenance contractor at the plant applied the Ceramic Repair Putty HT to three coal pulverizer doors, each approximately 50 sq. ft, in two shifts, ensuring that all the deep pitting was filled and the coating was brought to a total film thickness of 1/8 inch.

After 4 months, the doors were inspected and were found to be in excellent shape with no observable wear or corrosion.
