FEATURED PROJECT

Concrete Crack Repair with Carbon Fiber

Riverside Properties

Massachusetts

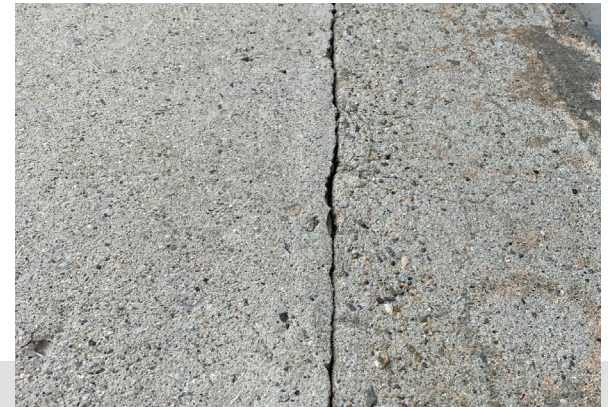
A loading ramp designed to support heavy-weight vehicle traffic at a manufacturing facility had cracks and concrete damage. An inspection found that the damaged sections of concrete had to be rebuilt and that the width of the cracks in the concrete ranged from hairline cracks to a 1/4 inch width. A solution was needed that would reinforce the ramp, eliminate further damage to the concrete, and ensure that existing cracks did not reform in a newly applied, light grey, UV-stable topcoat. In addition, the repair needed to be conducted in less than 48 hours to minimize the impact on deliveries.

Figure 1 Existing Crack In The Concrete After Power Washing

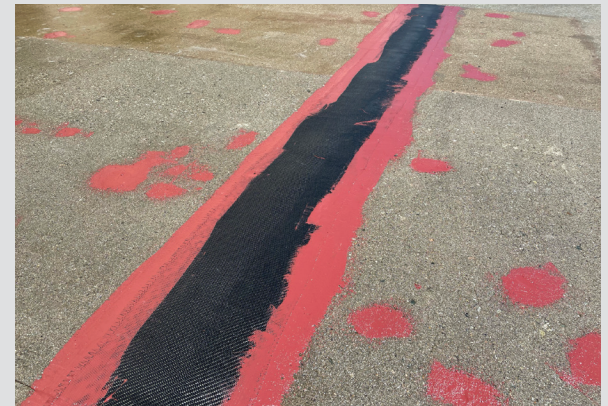
Figure 2 Crack Repaired with Epoxy Elastomer and Carbon Fiber Composite

1. After power washing the surface, a penetrating concrete primer, FRP 210 Sealer, was installed at 3 - 5 mils via roller
2. HP 300 Elastomer was poured into the cracks and troweled smooth, then a bond breaker was created by applying painter's tape directly over the filled-in cracks.
3. 12-inch width carbon fiber was saturated with our FRP 200 Saturant and applied over the entire length of the cracks.
4. FRP Repair Putty was used to reinforce spalling concrete, to fill in bug holes and to transition the carbon fiber edges.
5. HP 300 UV was applied at 15 - 20 mils over the entire surface.

The system was applied and fully cured within 48 hours and the loading dock was approved for full vehicular traffic.

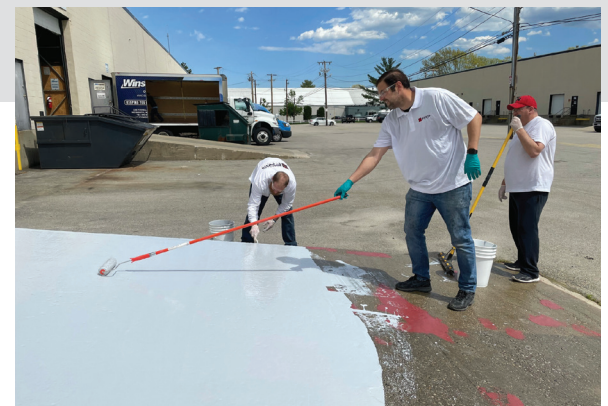
Figure 3 Application of the HP 300 UV Topcoat
