## FEATURED PROJECT

# Composite Repair of Fiberglass Chemical Storage Tank

**CUSTOMER**  
Aquapharma

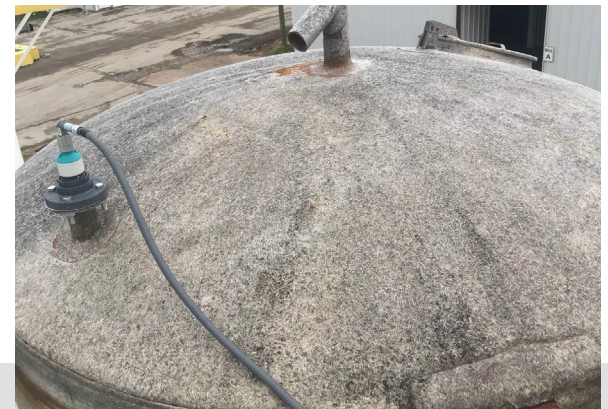
A chemical distribution facility found that several of their older fiberglass chemical storage tanks were experiencing degradation from chemical and UV exposure including cracking and delamination of the fiberglass. The most critical areas identified for repair were the junctions of the roof and side walls as well as the lifting lugs that were built into the tanks. In addition, the vent piping on the top of one of the tanks needed to be replaced. The facility required a solution that could provide long-term reinforcement of the tanks, was chemically-resistant, and could be installed with the tanks online.

Figure 1 Close-Up View of Tank Roof Prior to Repair

1. 60-grit sandpaper was used to aggressively sand the fiberglass.
2. FRP Repair Putty was applied to fill in any cracks and/or holes and smoothly transition any hard edges.
3. FRP 120 HT Adhesive was applied via brush/roller at 5 - 10 mils.
4. The CF-500 BD was saturated with FRP 211 HT Saturant and applied over the repair areas in multiple layers.
5. HP 300 Epoxy was then used to topcoat the repair area and allowed to cure for 24 hours.

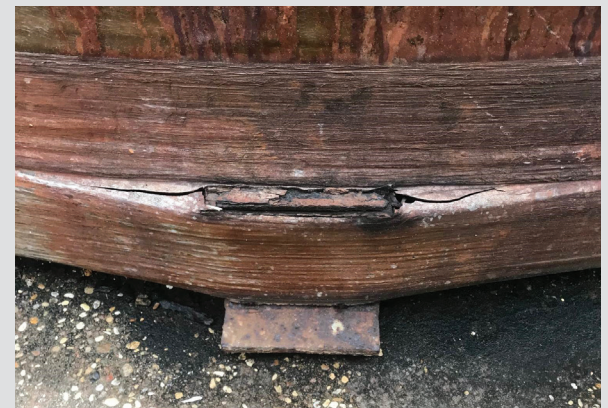
Figure 2 Cracking and Delamination of the Fiberglass at the Tank Base

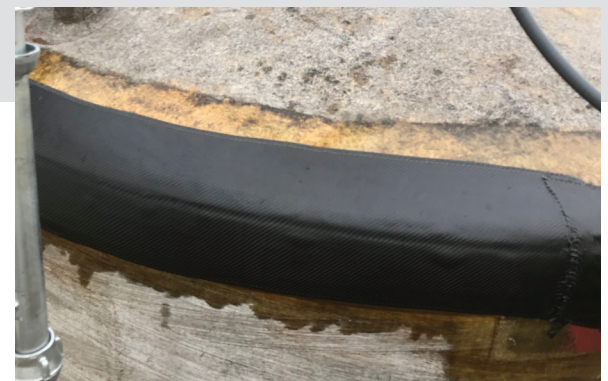
Figure 3 Carbon Fiber Repairs of the Vent Pipe, Tank Roof and Top Seam

The composite reinforcement was successfully installed without the need for expensive scaffolding; only manlifts were used where needed, and, without additional containment or environmental controls, even though the tanks were online and contained aggressive chemicals.
