# Composite Tank Repair

## INTERNAL COMPOSITE REINFORCEMENT OF A RAW WATER STORAGE TANK

Black Hills Energy

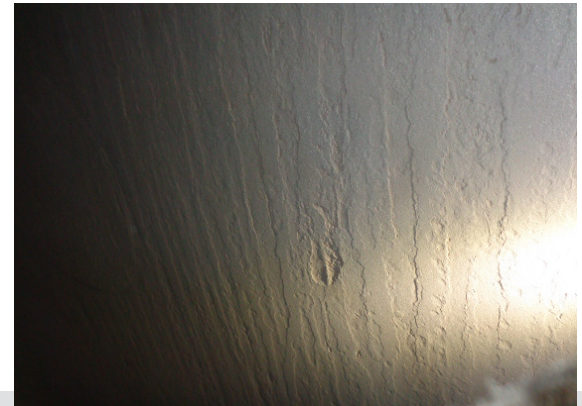
Inspectors at Black Hill Energy's Pueblo Airport Generating Station discovered severe internal corrosion occurring in a 400,000 gallon, 60 ft. diameter raw water storage tank, with many areas measuring below 50% wall thickness and several through-wall failures observed. The tank had not been internally coated with an immersion-grade coating system upon installation ten years prior, allowing widespread, severe corrosion to develop. An engineering firm was commissioned by the plant to determine an economical, long-term option for the critical tank. The firm reached out to Advanced FRP to determine if an internal reinforcement with carbon fiber was a viable solution.

Figure 1 Severe Corrosion and Pitting on the Tank Wall After Grit Blasting

Advanced FRP provided the engineering firm with the necessary theoretical calculations and case history to prove the long-term viability of composite reinforcement, even in badly corroded tanks. Ultimately, an internal carbon fiber composite reinforcement system with an immersion-grade coating was recommended.

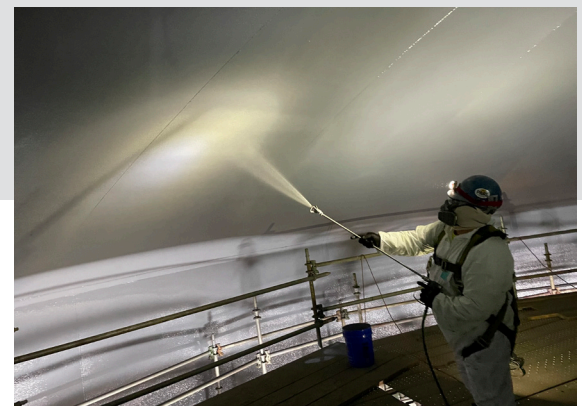
Figure 3 Application of HP 300 GF, an Immersion-Grade Coating System

1. The tank was grit blasted to an SSPC SP-10 Near White Metal finish with a 3 mil angular profile.
2. HP 300 GF, an immersion-grade epoxy coating, was applied to protect the roof and floor of the tank and act as a galvanic barrier on the tank walls. Pitting and irregularities were smoothed with FRP Repair Putty.
3. FRP 110 HT Tack was applied to the wall via roller to aid application. The carbon fiber (CF-500 BD) was then saturated with FRP 210 HT saturant and hand-applied to the wall and floor-to-wall joint.
4. HP 300 GF was then applied over the composite via airless spray.
