TANK SPOT REPAIRS

COMPOSITE TANK REPAIR

REPAIRING SMALL DIAMETER TANKS FOR OIL & GAS

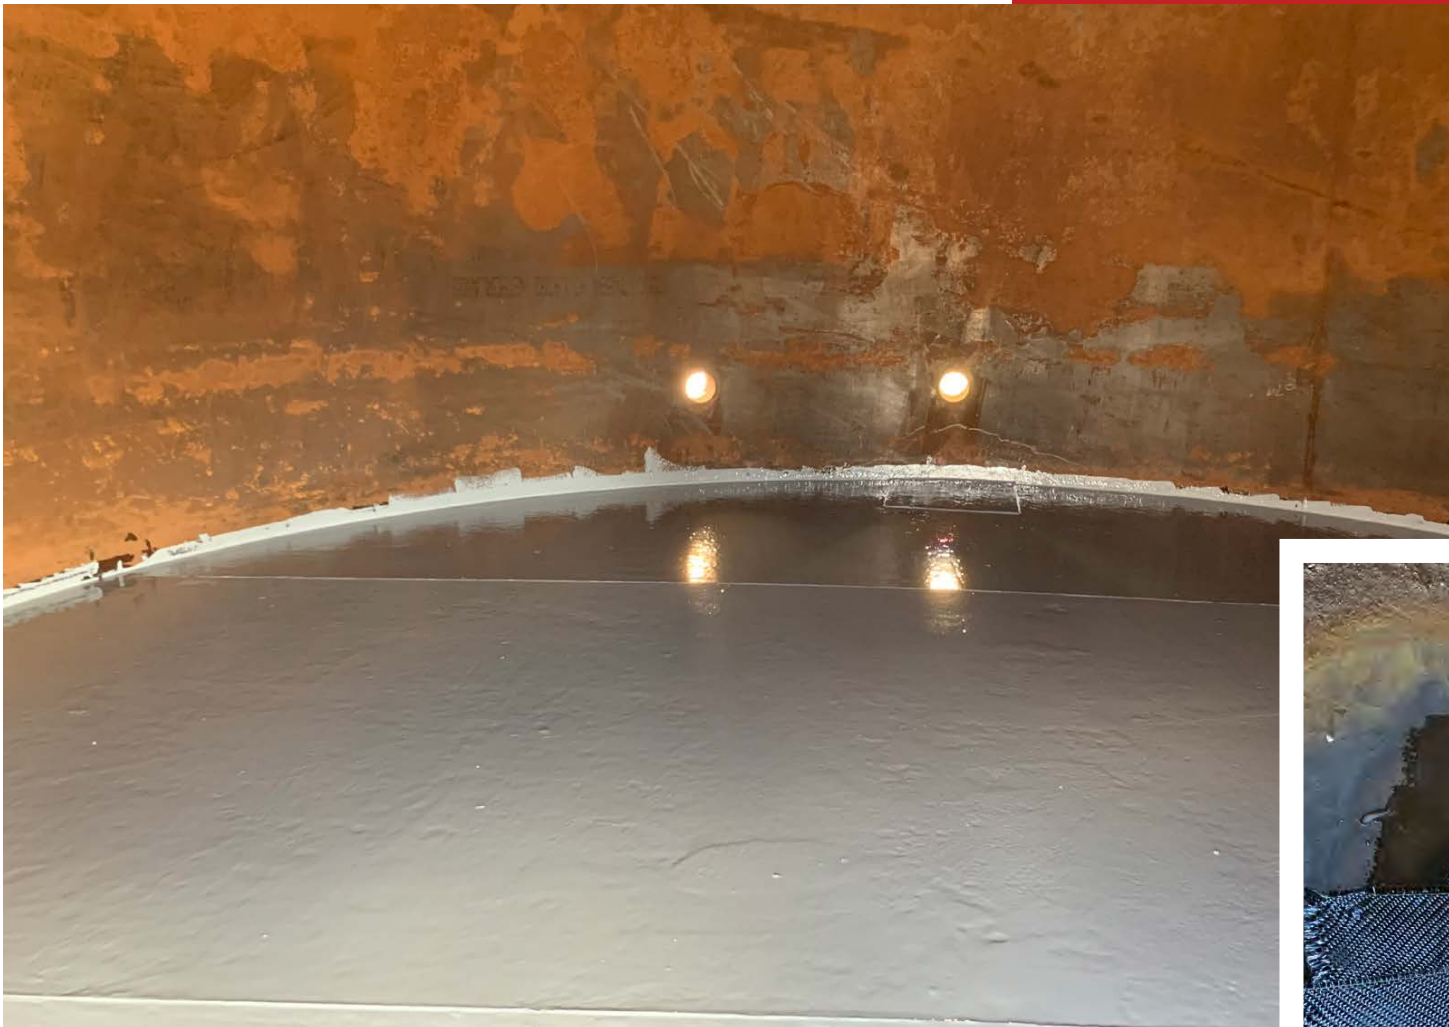
In this project, small diameter (10-foot) tanks procured from major oil companies needed repairs. After inspecting the tank, several issues were discovered, including throughwall holes and major corrosion pitting.

The selected solution involved using composite repair techniques, which included reinforcing fabric and epoxy resin binders, to restore the structural integrity of the tanks. These composite repair patches not only halted ongoing corrosion but also served as a protective barrier against future deterioration.

The installation process included grit blasting and inspecting the tank floors for damage. Identified through-wall failures were swiftly repaired using composite materials, reinforcing the tank and sealing leaks. An epoxy flood coat was applied to halt ongoing corrosion and provide protection.

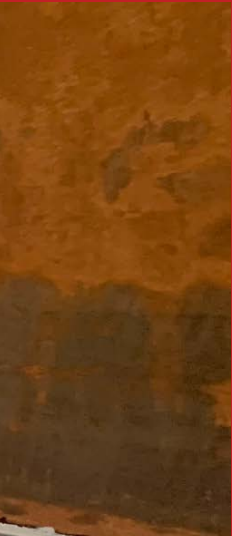
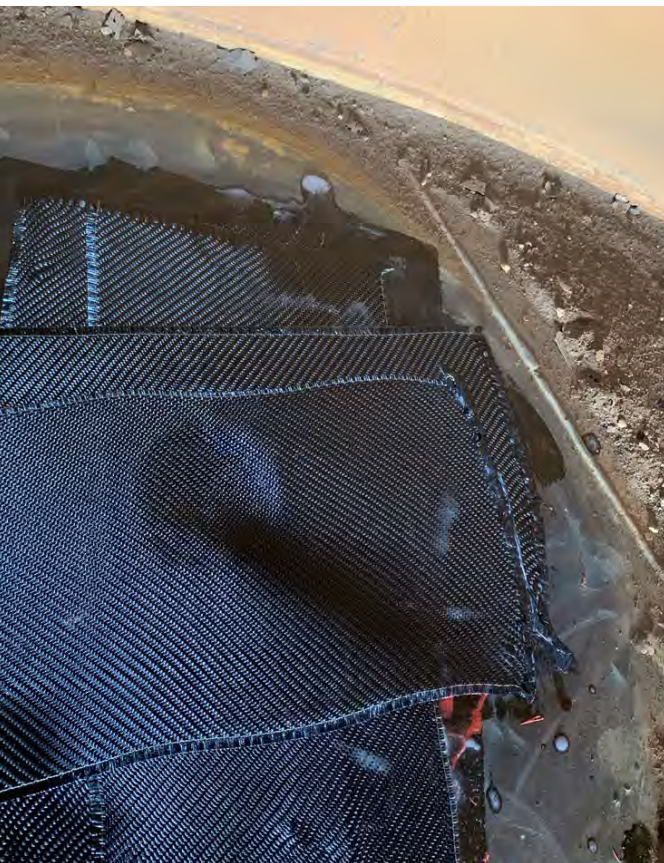
The tanks required refurbishment to be repurposed effectively. The leaks and deterioration from corrosion required an easy-to-apply and cost-effective solution that could address the issues efficiently.

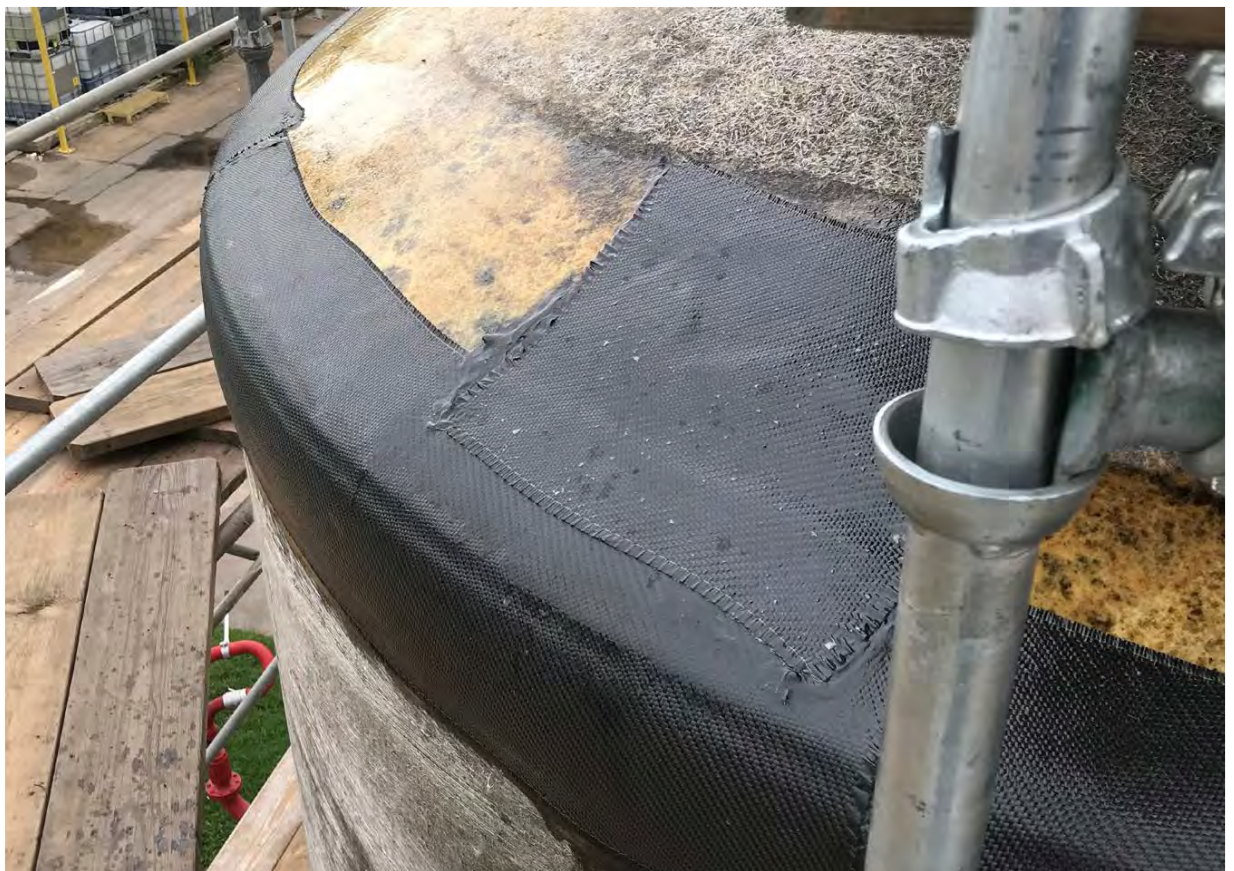
The tanks suffered from chemical and UV degradation, leading to problems like cracking and delamination, primarily affecting the roof and side walls. The facility needed a long-term reinforcement solution that could be applied while the tanks were operational.

The solution chosen was a long-term reinforcement approach capable of addressing existing issues and enduring chemical exposure. Importantly, it allowed for online installation, ensuring the tanks could stay operational during reinforcement. The selected carbon fiber composite system offered a high modulus, strong adhesion, and long-term fatigue resistance.

The reinforcement was successfully installed without the need for scaffolding, which lowered the overall cost of the repair.

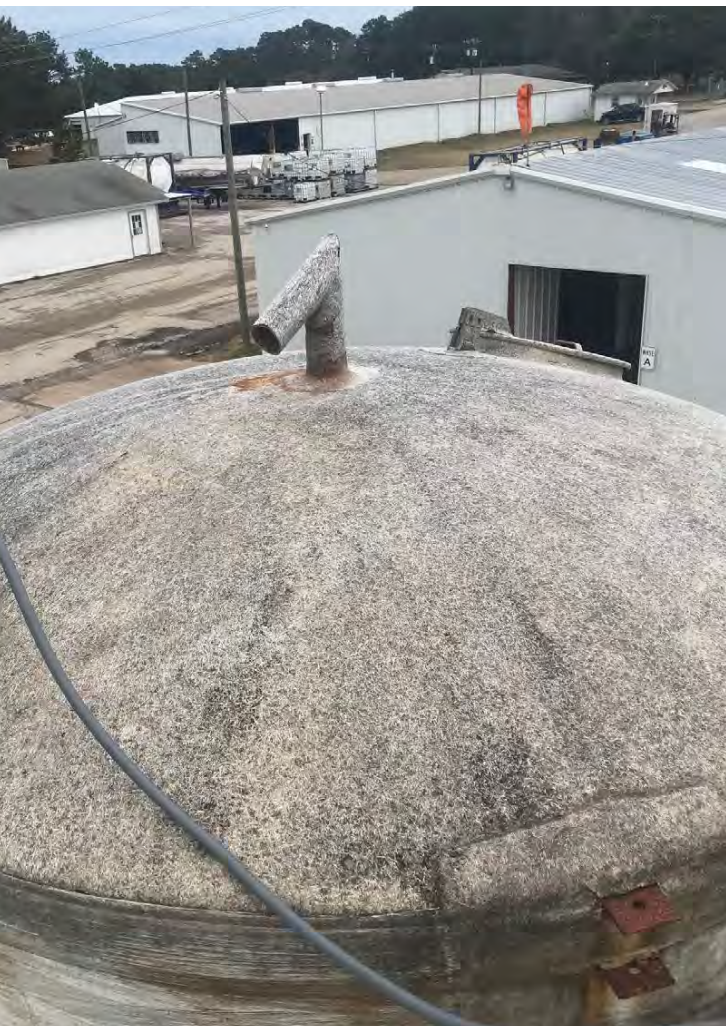
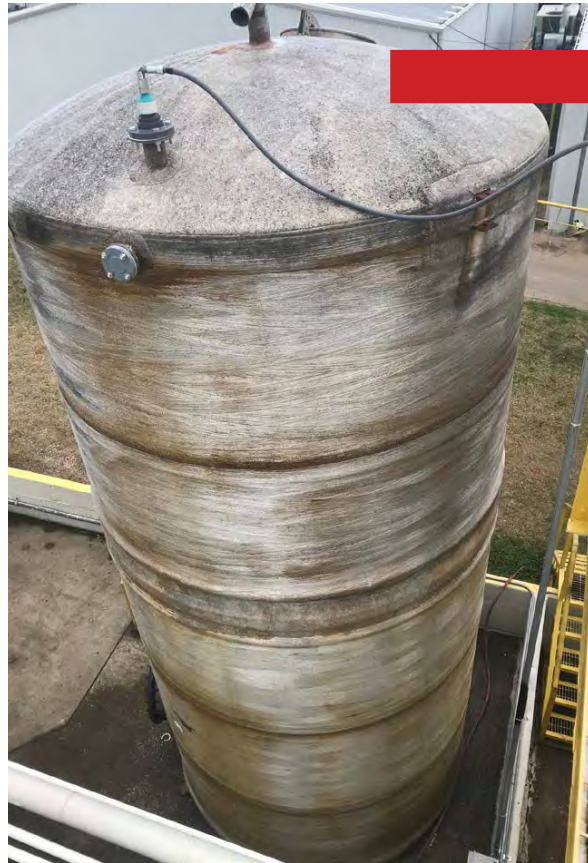
A chemical distribution facility housed older fiberglass chemical storage tanks in need of repair.

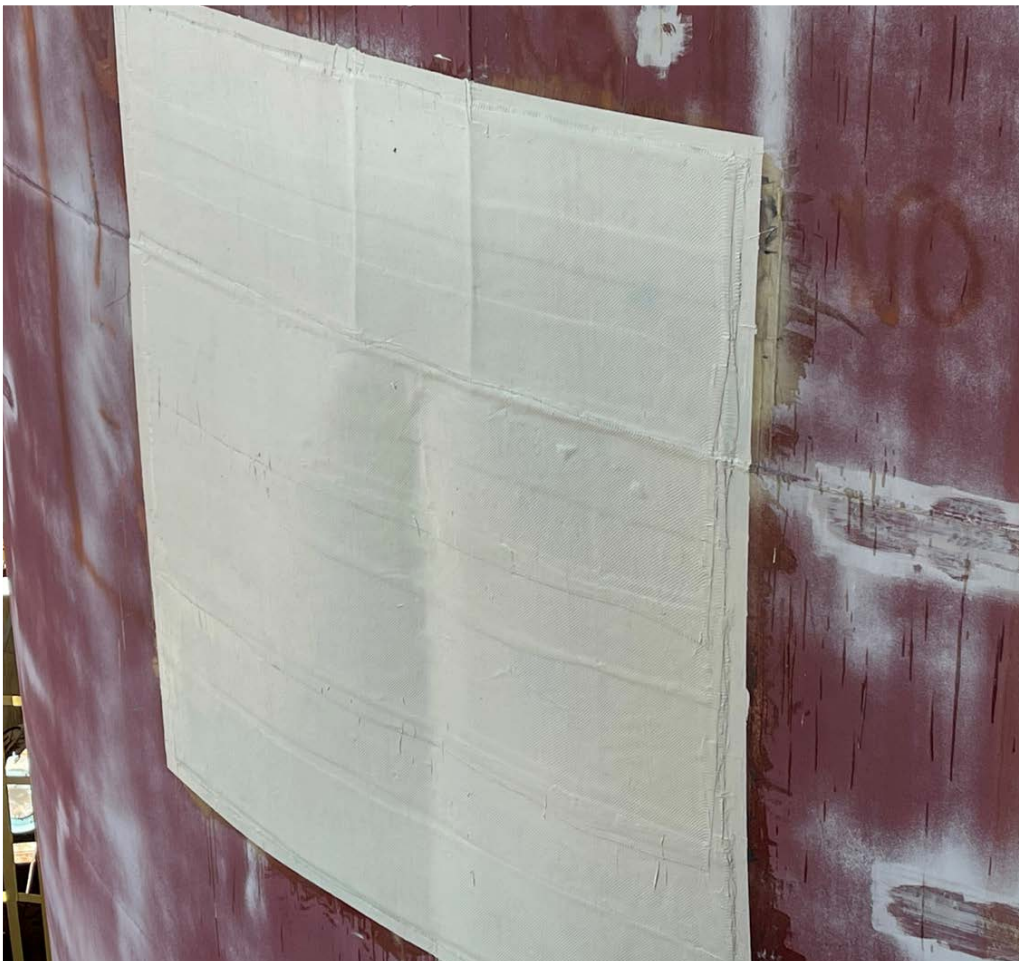
A pulp and paper facility faced issues with a large scavenger tank, including corrosion, buckling, and pinhole leaks. An assessment revealed that spot reinforcement was sufficient. The facility sought a solution to strengthen the tank structurally while also addressing corrosion and pinhole leaks.

An 8 ft x 12 ft composite carbon fiber patch proved to be an excellent alternative to externally welding a steel plate. This innovative repair solution incorporated a combination of materials, including FRP Repair Putty, CF-500 BD fabric, FRP 210 HT, and HP-400 Novo.

The incorporation of bidirectional fabric in this repair process was perfect because of its versatility and ease of installation, ensuring an effective and efficient solution for the repair.

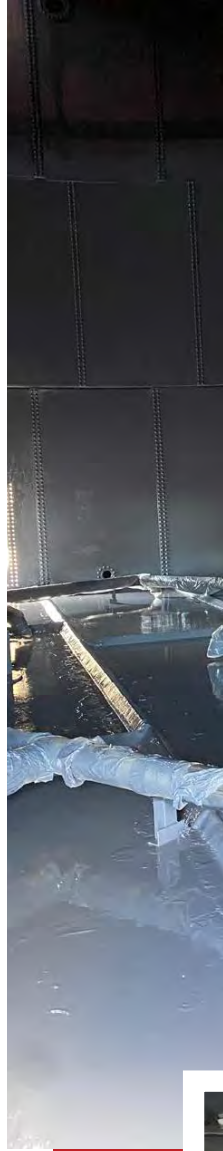
A company in the oil and gas industry specializing in wellsite wastewater removal and processing was experiencing through-wall failures and leaks of oily water in one of its storage tanks.

An immersion-grade, chemically-resistant epoxy novolac coating system, HP-410 GF, was installed inside the tank. The coating was allowed to cure at room temperature, and the entire tank was subjected to high voltage holiday detection. Any holidays were repaired, and the tank was returned to service.

Upon return to service, multiple leaks in the tank were observed. After further review, it was found that the leaks were coming from a new area — the tank walls. After a consultation with the tank manufacturer, Advanced FRP Systems recommended that the bolts be tightened. After two rounds of tightening the wall bolts, the leaks were resolved, and the tank was officially returned to service.

The tank has a MIC-resistant novolac epoxy coating system over the entire tank surface to protect the tank from further corrosion. The carbon fiber composite patches used to repair through-wall failures extend at least six inches past the holes in all directions and provide greater than 3,000 psi adhesion to blasted steel, ensuring the repairs' longevity.

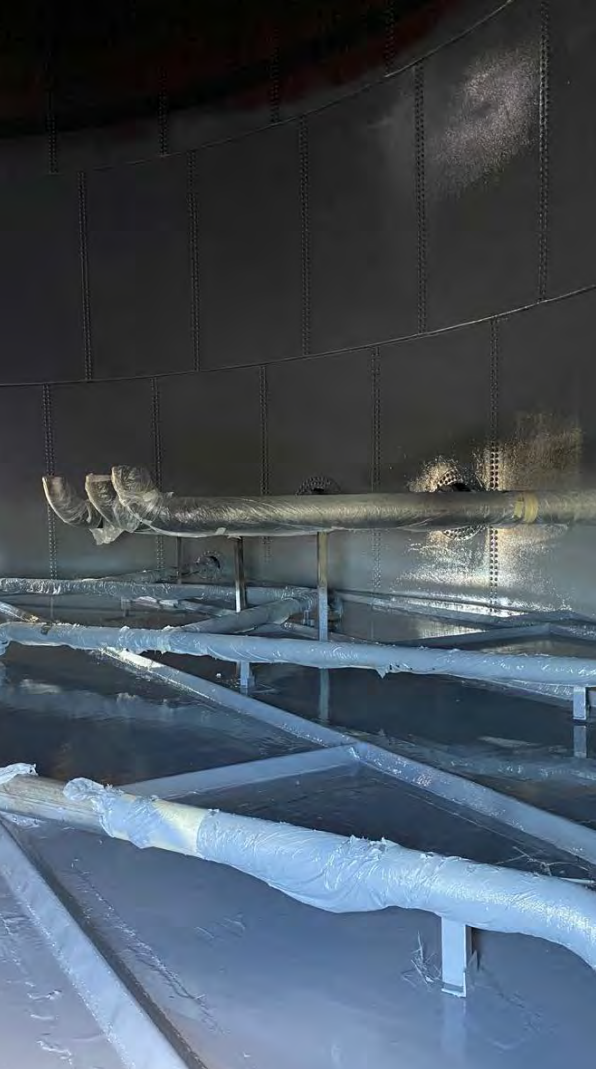
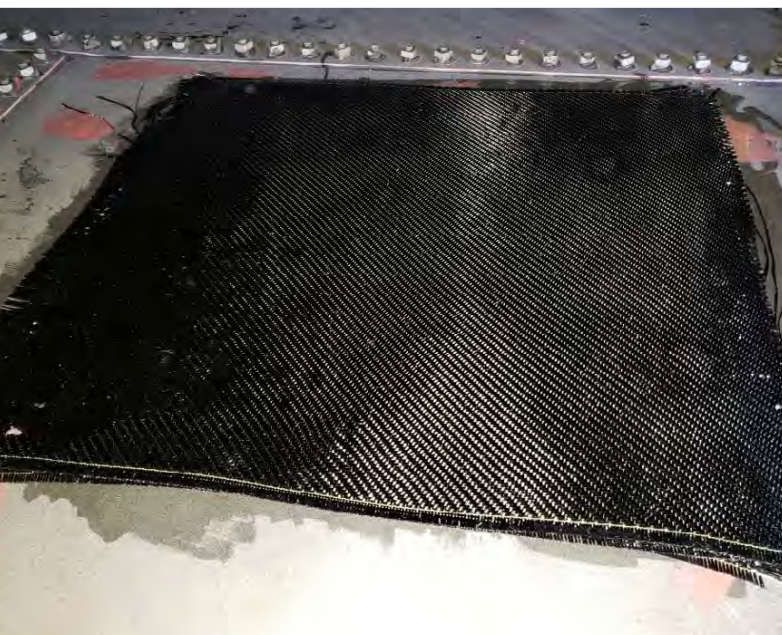
Bolted tank designs often include an internal coating when the tanks are built. Unfortunately, these internal coating systems are often inadequate for long-term water-immersion service. Finding the root cause of a leaking tank is difficult to determine without a detailed inspection that can only be performed after a storage tank is drained.
