# CRITICAL OUTLIERS

SOLVING THE MOST  
CHALLENGING CASES WITH  
COMPOSITE SOLUTIONS

## COMPOSITE PIPE REPAIR

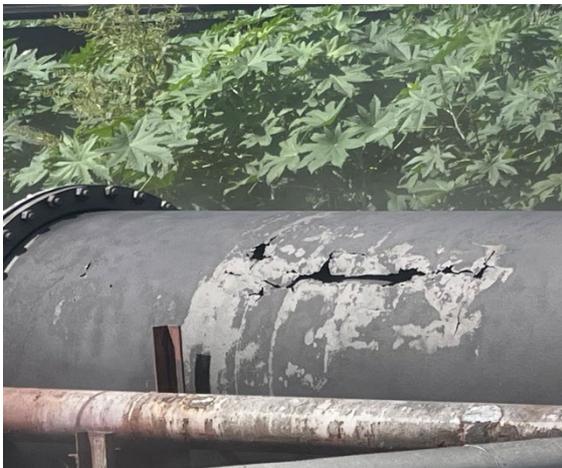
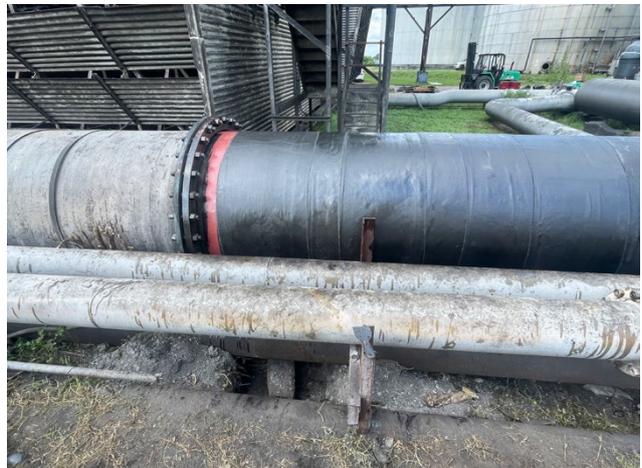
# REINFORCING A CRITICAL COOLING WATER PIPE WITH CARBON FIBER

## PERMANENT REINFORCEMENT EXTENDS SERVICE LIFE OF CRITICAL PIPELINE BY 50 YEARS

Inspectors at a sugar processing facility found frequent leaks in a critical cooling water pipe. The pipe's ultra-thin wall was severely dented from an over-tightened repair clamp and had to be restored to shape with filler putty prior to any repairs. Advanced FRP recommended a repair using a structurally independent, carbon fiber reinforcement system

that would be installed around the existing pipe. High ambient temperatures made the carbon fiber fabric extremely hot to touch during application. Despite these challenges, the composite system delivered permanent reinforcement without service disruption, providing a 50-year life extension to the critical pipeline.

**FRP Repair Putty - CF-500 BD - FRP 211 HT Saturant  
- HP 300 Epoxy**

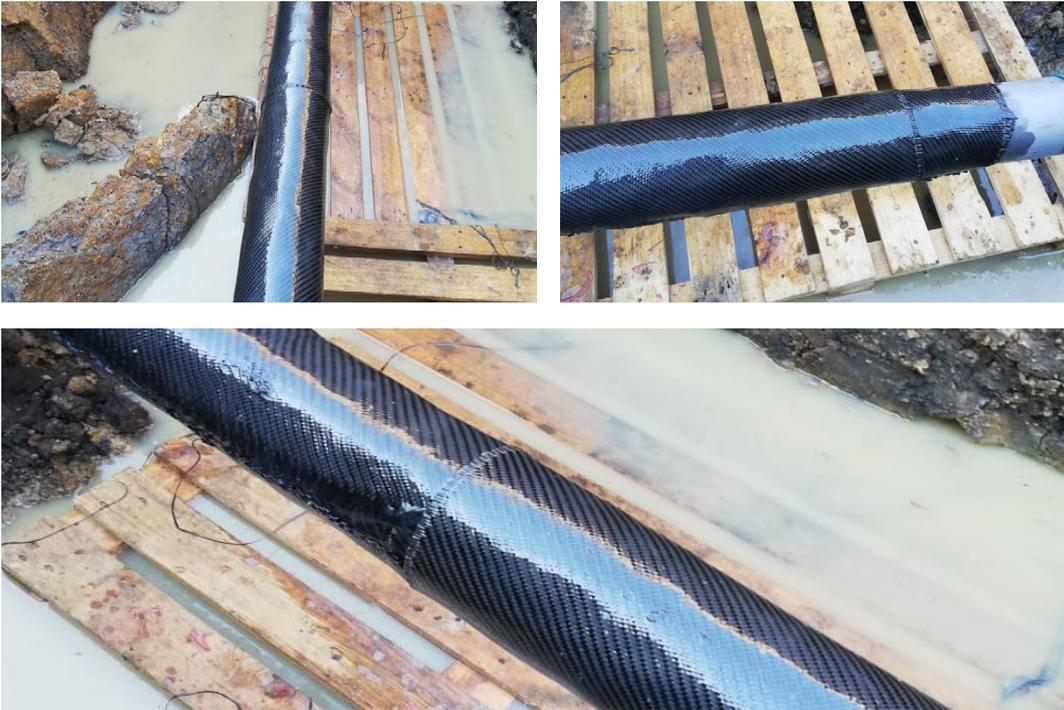
# HYDROGEN PIPELINE REPAIR

## 6-LAYER, CARBON FIBER REINFORCEMENT SYSTEM

A major gas company found defects on the weld seams of a stainless-steel pipe that transported pure hydrogen gas. The defects were likely stress corrosion related so the company turned to a high-modulus carbon fiber system to reinforce their critical stainless-steel

hydrogen pipeline. In this case it was important to use materials that wouldn't react adversely with hydrogen, as some steels can. A six-layer carbon fiber reinforcement system was applied to a two-meter length to enclose both problematic areas and provide a long-term life extension.

**CF-500 BD - FRP 210 HT Saturant - FRP 120 HT Adhesive - FRP Repair Putty - HP 300 Epoxy**

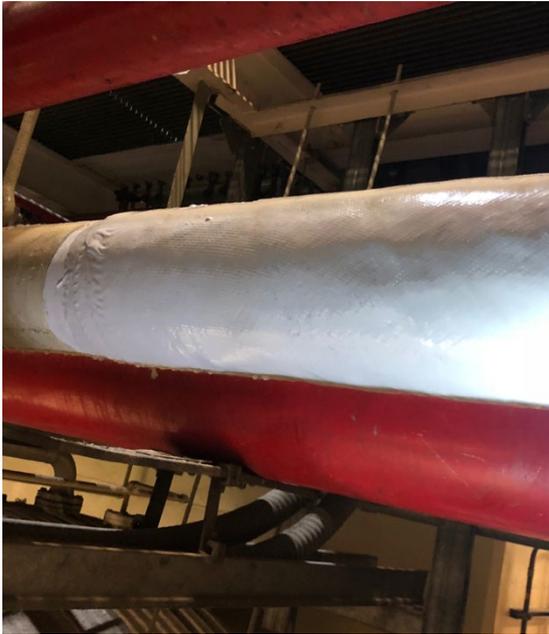
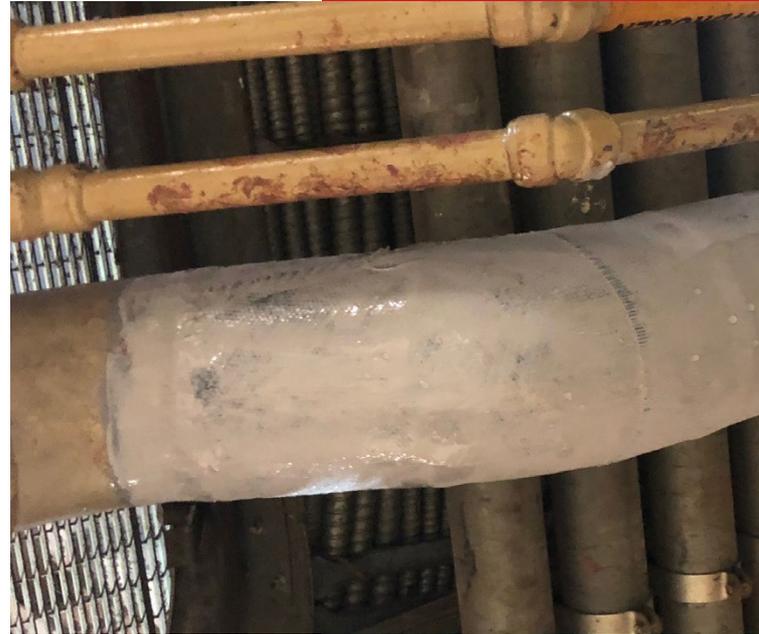
# LONG-LASTING REPAIR FOR NUCLEAR POWER PLANT

## Carbon Fiber Repairs Leak in Circulating Water Pipe

Nuclear power facility managers discovered a pinhole-sized leak in a 42-inch diameter circulating water pipe. Nuclear environments present unique challenges, including limited access windows, strict regulatory oversight, and zero tolerance for failure. As a result, the repair had to be fast, durable, and non-disruptive to operations.

**CF-500 BD - FRP 210 HT - HP-300 Epoxy  
- FRP 120 HT**

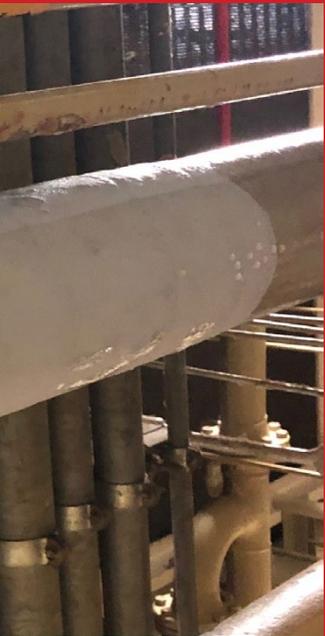
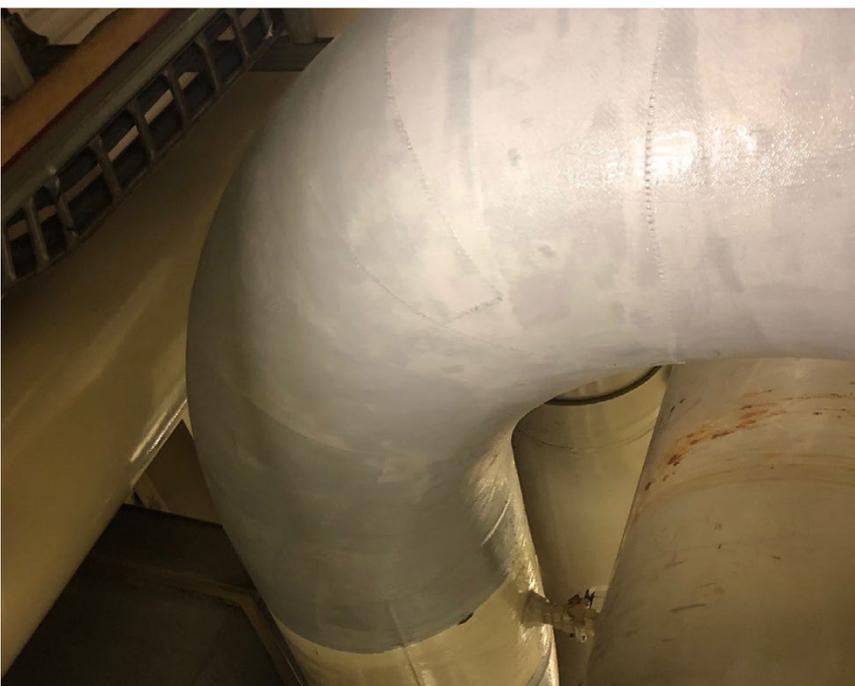
# Composite Reinforcement of Pinhole-Sized Leak

First, the large diameter water pipe was bristle blasted, followed by the installation of 3 layers of high-strength carbon fiber and a 100% solids epoxy topcoat. This composite repair restored structural integrity without hot work or extended downtime.

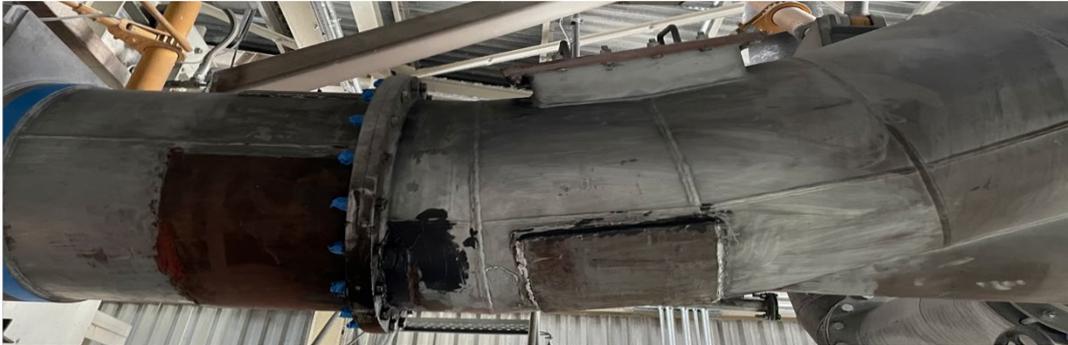
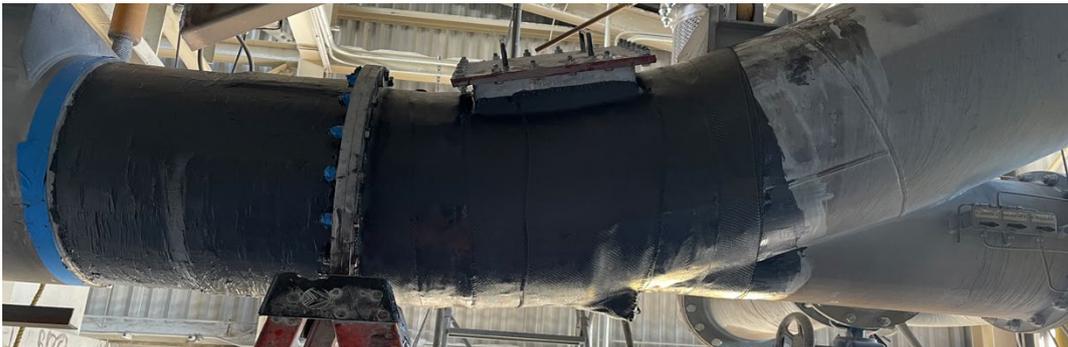
# REPAIR FOR COAL HANDLING PIPE

## **INTERIM SOLUTION - CERAMIC-LINED, CARBON FIBER PATCH APPLICATION OVER EXISTING Y-SECTION**

Inspectors at a concrete facility found frequent leaks in a Custom Y section of their coal handling area. The operators wanted to replace the custom pipe but faced an extended lead-time for the item. A temporary solution was created where a ceramic-

lined, carbon fiber patch would be applied over the existing Y-section. The repair was installed while the system was online and during surface temperatures of 150°F. The patch provided a 2-year service extension.

**Ceramic Repair Putty HT - FRP 210 HT Saturant - CF-300 BD - CF-500 BD - HP 300 Epoxy**

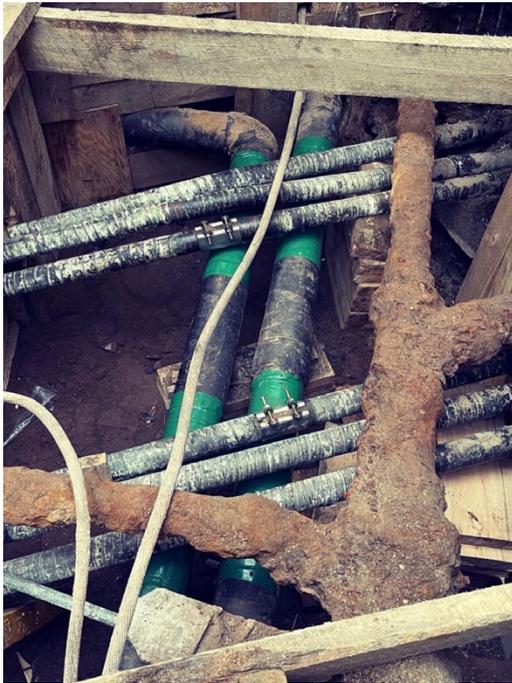
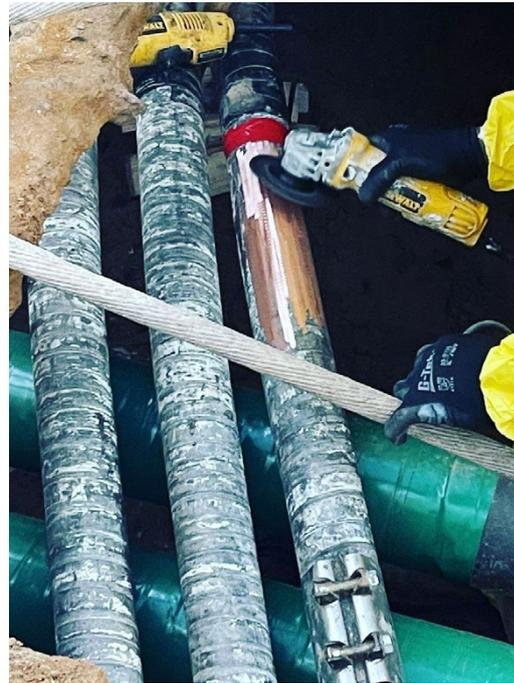
# SMALL DIAMETER HPFF CARBON FIBER REPAIR

## 6-LAYER, CARBON FIBER WRAP REPAIR

A dielectric fluid leak was found in several small diameter high-pressure, fluid-filled feeders near a substation. The pipe-type cables had a copper outer pipe and very low clearance around each pipe. A typical welded sleeve or clamp could not be used because of the

tight clearance. After a temporary leak stop was installed, six layers of high strength carbon fiber was wrapped around the pipes. This six-layer system provided a permanent repair for these copper, pipe-type cables.

**CF-500 BD - FRP 210 HT Saturant - Repair Putty - HP  
300 Epoxy - FRP 120 HT**
