# WATER & WASTEWATER APPLICATIONS

COMPOSITE &  
COATING REPAIR  
SHOWCASE

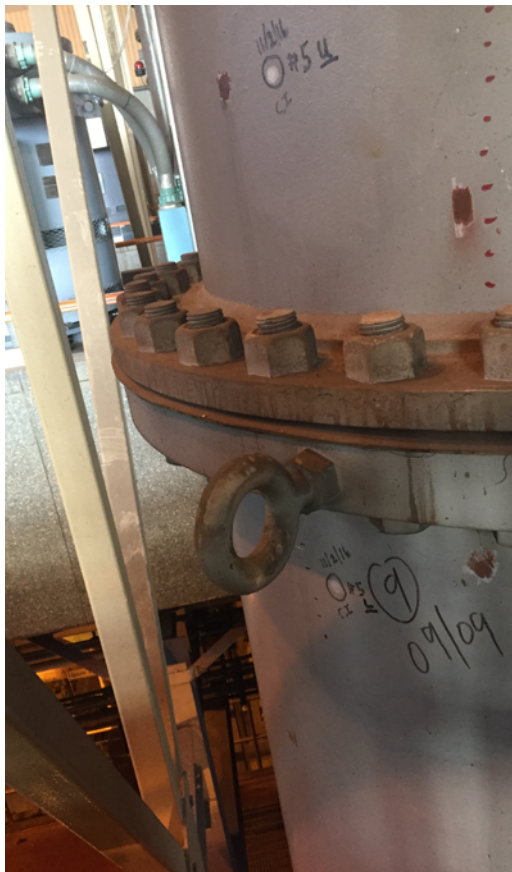
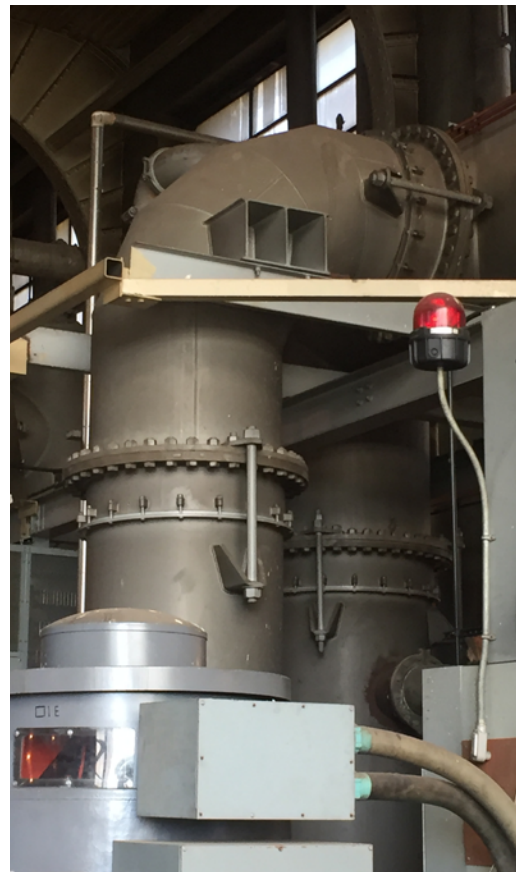
# RAW SEWAGE INTAKE PIPING

## COMPOSITES FOR COMPLEX GEOMETRIES

Frequent pinhole leaks at a wastewater treatment plant in Brooklyn, NY posed a major challenge. The pipes either needed to be replaced, which would require a full plant shutdown, or a long-term repair needed to be installed. The pipes ranged from 30-60" in diameter and included

complex geometries, such as pipe supports, dresser couplings, and flanged joints. Composites were ideal because they could be molded to the correct shape. The client repaired the leaks with high-strength carbon fiber composite.

CF-500 BD, FRP 200, FRP 110 Tack

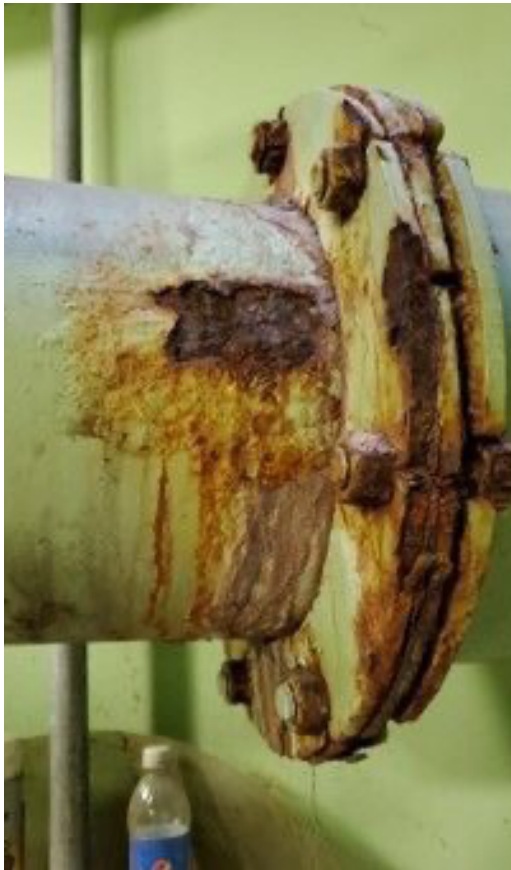
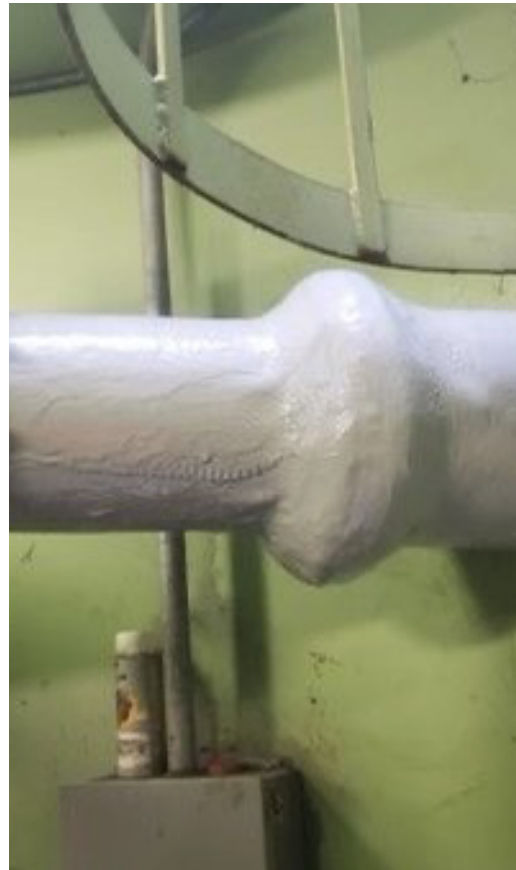
# FIRE MAIN PIPING SYSTEM

## REPAIR FOR PIPE SEGMENT CAST INTO CONCRETE

Internal and external corrosion at a flanged connection caused a leak in a fire main piping system and threatened the structural integrity of the connection. Replacement of the pipe was difficult, as the pipe segment was cast into the concrete wall. A composite carbon

fiber wrap was installed, completely encapsulating the flanged connection, to provide a long-term solution. The carbon fiber composite prevented future leaks, stopped external corrosion, and structurally reinforced the corroded flanges.

CF-500 BD, FRP 200 Saturant, HP 300 Epoxy

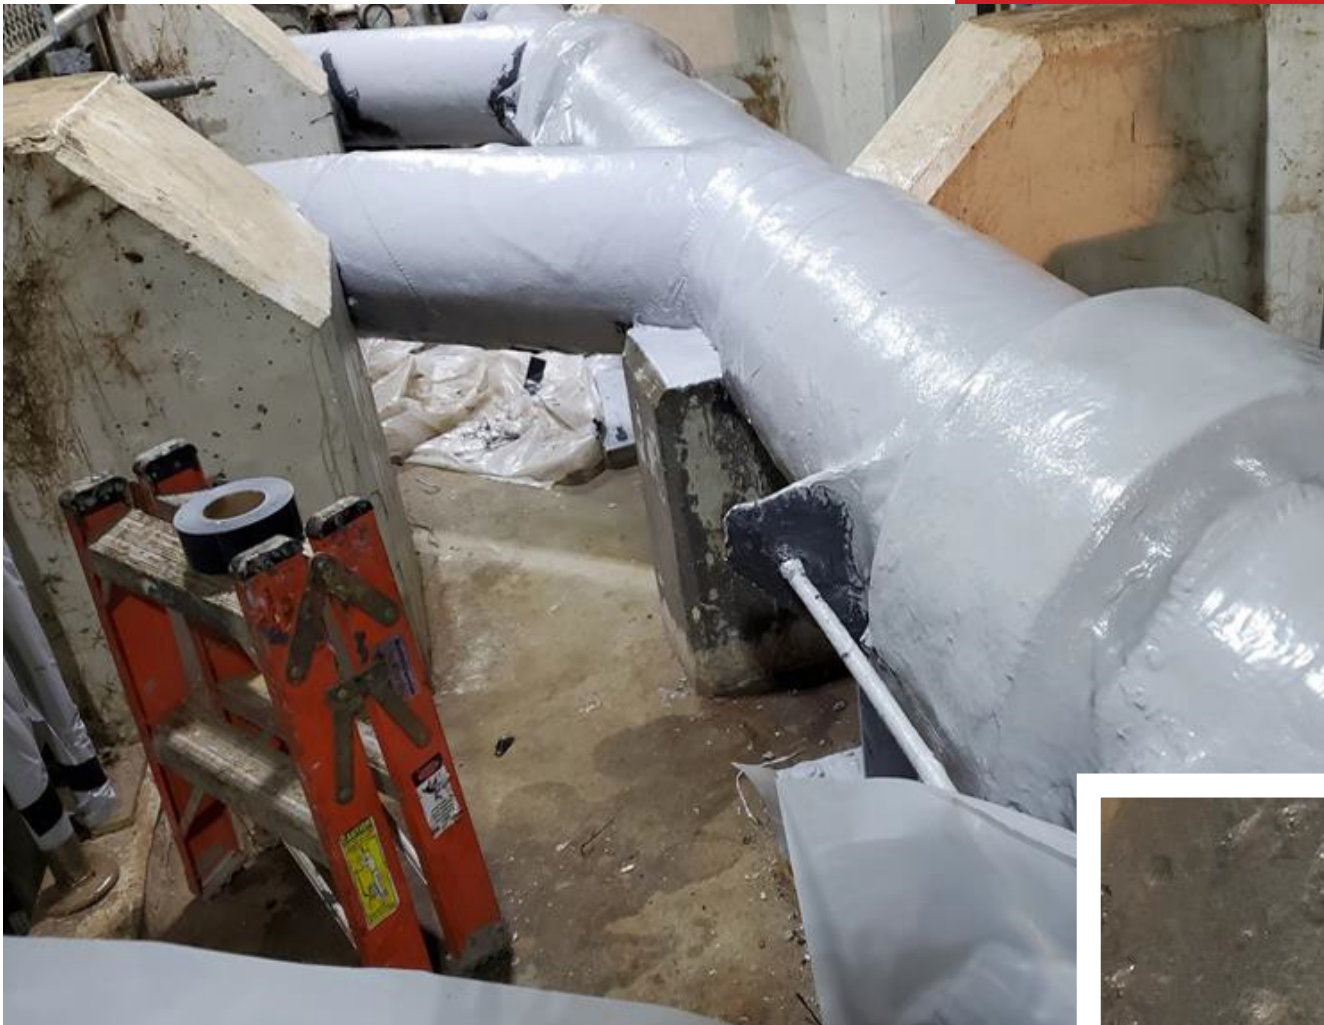
# SEVERELY DEGRADED LARGE DIAMETER PIPELINE

CF-500 BD, FRP 200, HP-300 Epoxy

## LONG-LASTING, EFFECTIVE REPAIR

The severely degraded pipeline was repaired with a composite repair system capable of withstanding 3 times the operating pressure and preventing leaks even with continued internal corrosion. The long-lasting repair has a maintenance-free, 50-year life expectancy.

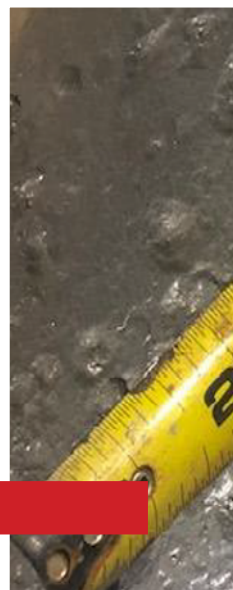
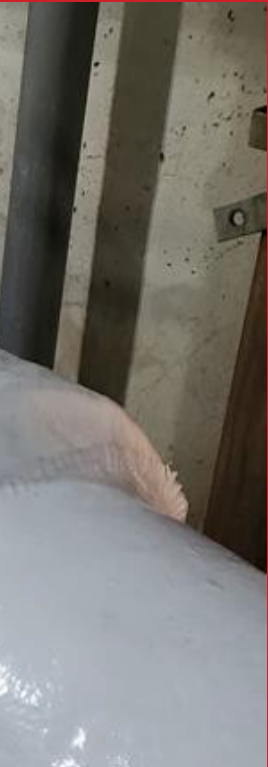
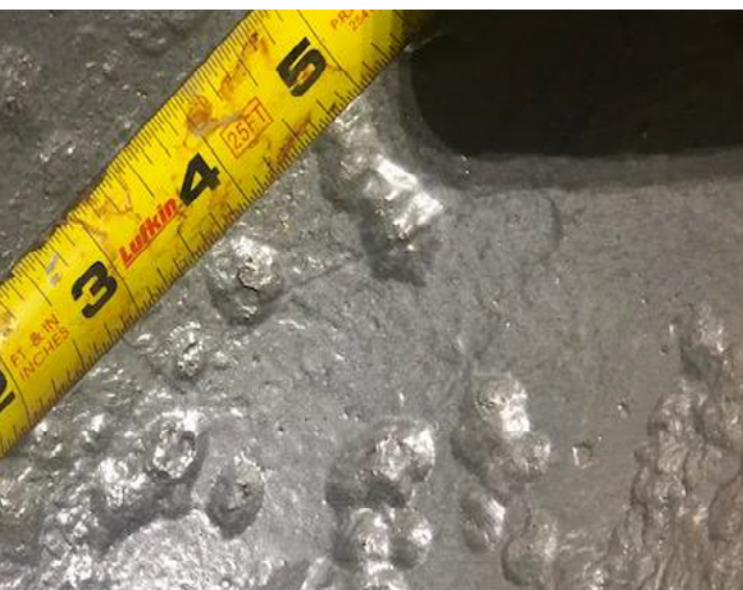
# Multi-Phased Approach to Comprehensive Composite Repair

A large diameter pipe at a pumping station with severe internal corrosion and a very complicated geometry needed to be repaired with the assets were online. After lightly sandblasting the pipeline to avoid further damage, extensive degradation and severe pitting were revealed.

The application company first applied an anti-corrosive coating for steel structures. Then, a synthetic metal compound for rebuilding damaged steel was applied over a dresser coupling void. Two layers of Advanced FRP System's carbon fiber composite repair were wrapped over the entire pipe surface, including the support structures. The finished repair was then coated with an epoxy top coat.

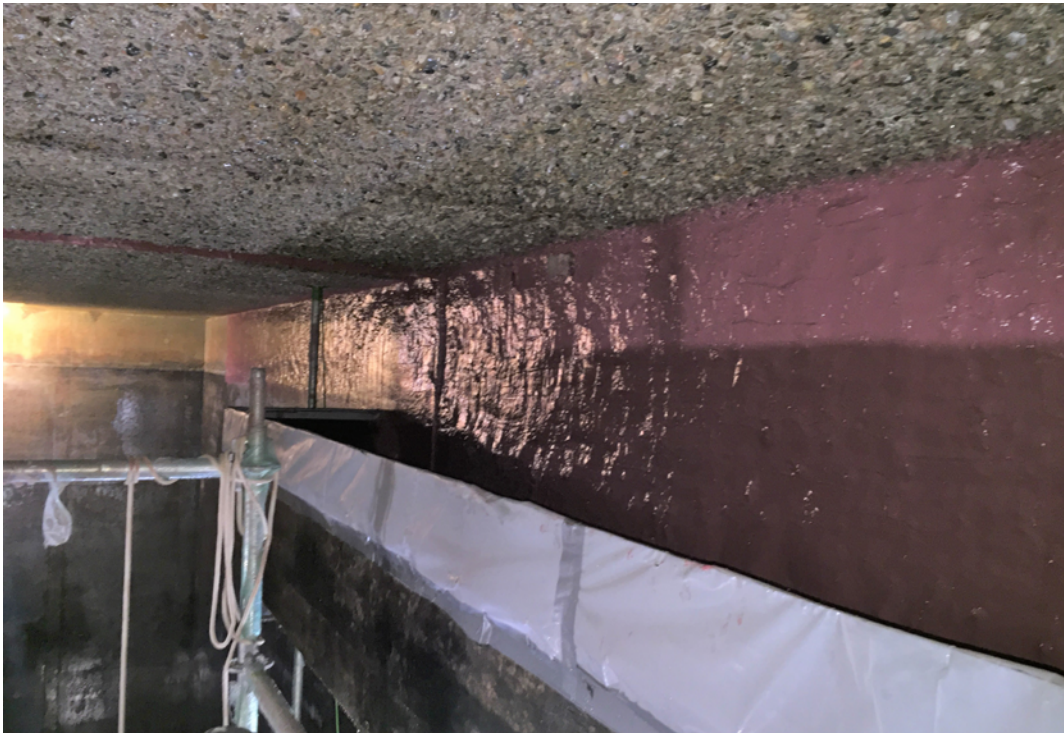
# WASTEWATER CONCRETE HOLDING TANKS

## SEVERE DEGRADATION SEAMLESSLY REPAIRED

A wastewater treatment plant had two concrete holding tanks for raw sewage. The tanks were experiencing severe degradation of the concrete above the vapor zone, most likely due to high levels of hydrogen sulfide gas. The tanks were drained, and over 3 inches of concrete was missing. The concrete was rebuilt

with Advanced FRP System's EM-110, a high-compressive strength epoxy mortar. The concrete was then coated with SL-310, a high-build epoxy coating system. The SL-310 was spray applied at up to 250 mils thick in a single coat to provide a seamless finish, even when rough aggregate was exposed.

SL-310, EM-110

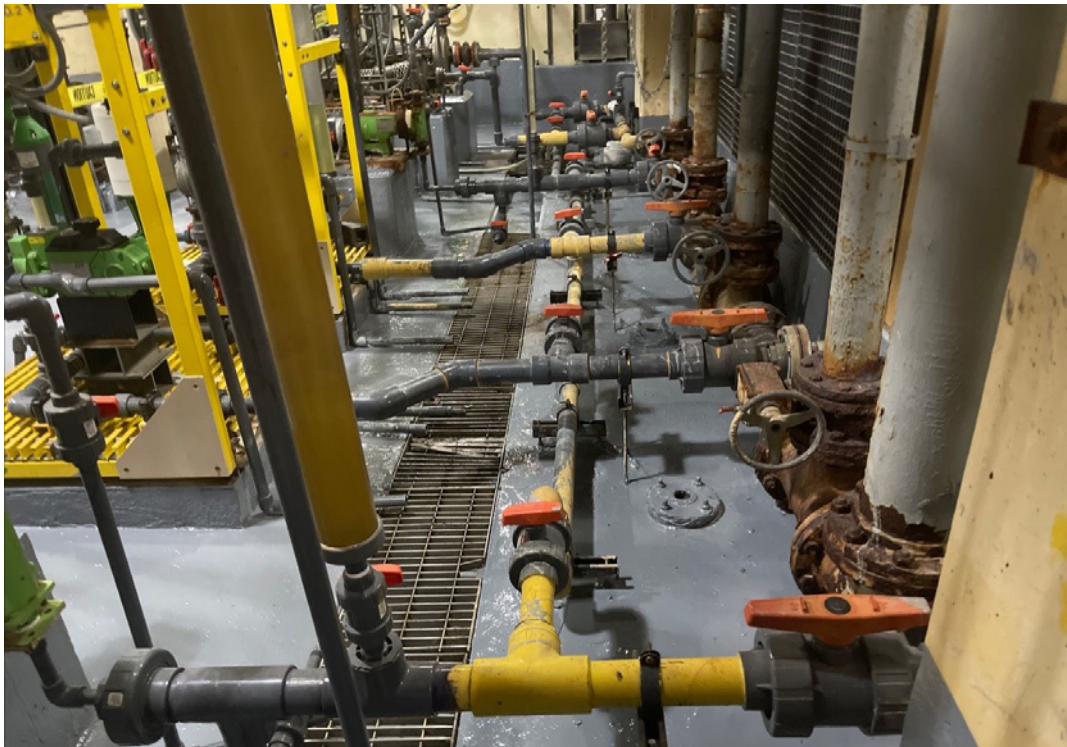
# BLEACH CONTAINMENT AREA FOR WASTEWATER PLANT

## LONG TERM SOLUTION FOR AGGRESSIVE CHEMICALS

A bleach containment area of a wastewater treatment plant required a repair due to degradation of the concrete. A new coating system was needed that could withstand exposure to frequent spills of concentrated sodium hypochlorite (bleach). HP 400 Novo was

applied in two easy-to-install coats via roller to provide long-term protection and excellent chemical resistance. The 100% solids, solvent-free coating cured at any thickness, ensuring consistent quality throughout the repair.

FRP 200 Sealer - HP 400 Novo

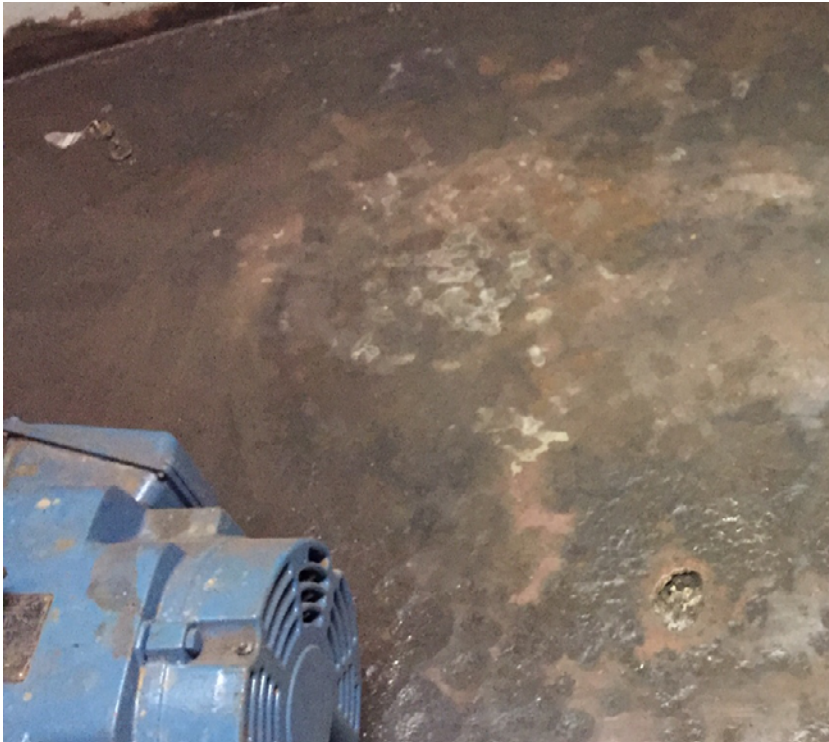
# UNDERGROUND PUMPING VAULT

GF-300 BD - FRP Repair Putty - HP-300 Elastomer

## SOLVING INTERNAL CORROSION AND IDENTIFIED THROUGH-WALL FAILURES

During an inspection, a water treatment plant found groundwater was leaking into the chamber of one of its underground pumping vaults. The damage was primarily attributed to internal corrosion of the steel on the floor and lower sections of the wall, with multiple through-wall failures identified. A solution had to be installed that would prevent groundwater infiltration, reinforce the corroded floor-to-wall joint, and resist periodic immersion in water with a high salinity. The solution also needed to be installed without grit blasting the repair area, as the sensitive pumping equipment could not be removed or safely protected.

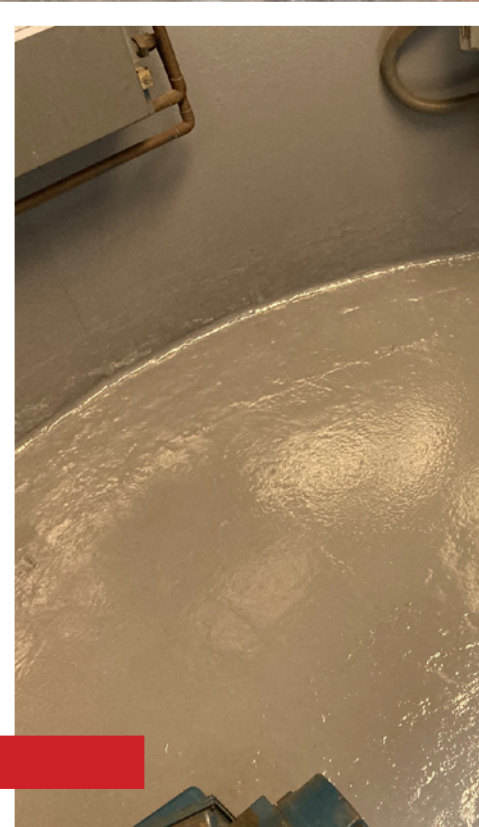
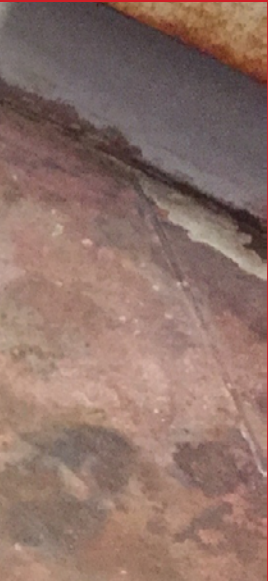
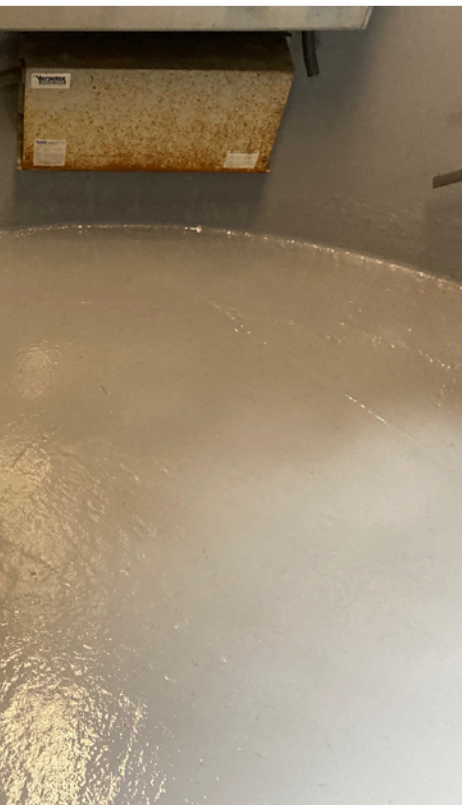
# COATING REPAIRS ENGINEERED FOR SUCCESS

To prepare the repair area, the failed existing coating was removed via Bristle Blasting, and a surface-tolerant epoxy primer was installed to maximize adhesion to the exposed steel. Pitting and holes were filled in with a high-build epoxy putty then reinforced with two layers of a high-strength woven fiberglass mat. An elastomeric epoxy was then applied to minimize any stress from thermal cycling and provide maximum impact and abuse resistance to the cured system.

1. The steel was Bristle Blasted then primed with FRP 201 Sealer.
2. FRP Repair Putty was used to fill in existing pitting and provide coves in the corners.
3. Fiberglass was saturated with FRP 200 Saturating resin and installed around the circumference of the vault to reinforce the floor-to-wall joint.
4. Two layers of HP-300 Elastomer were applied via roller at 15 – 20 mils per coat.

The final system provided an immersion-grade, reinforced epoxy that tied into the existing internal coating to prevent future corrosion from the inside of the vault.
